# Addressing Drainage Issues at Trees for Canterbury: A microscale hydrological survey

Yasmin Kesry, John Arkless, Shihu Wang, Jordan Sadeghi

University of Canterbury - 18/10/2025

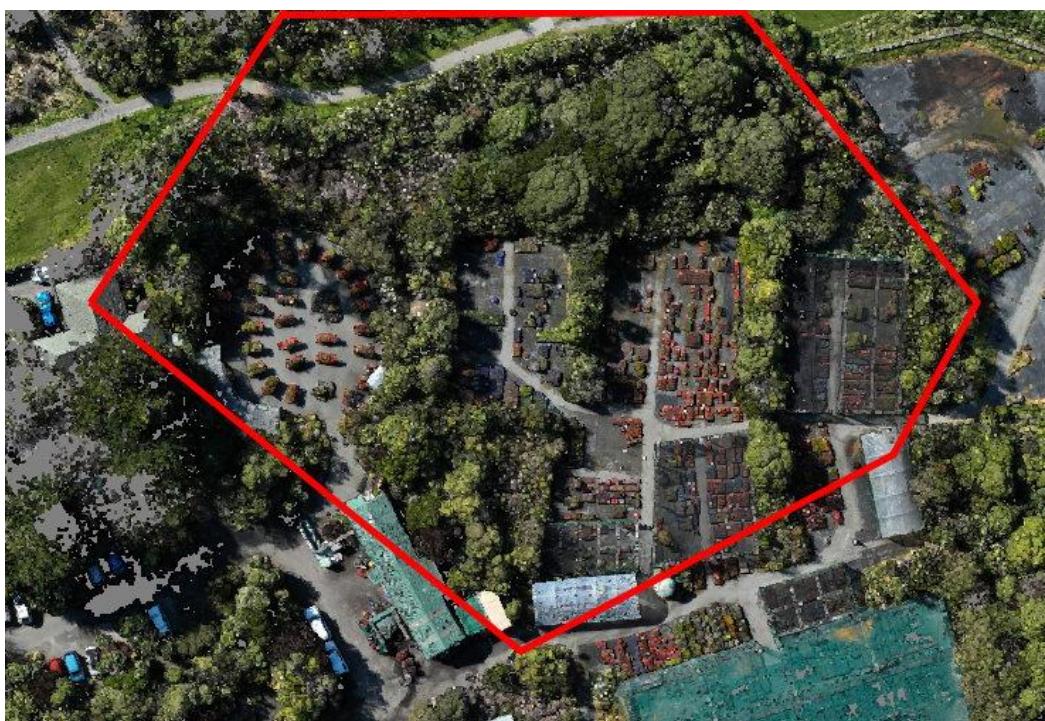
Figure 1: Study area

The TFC site occupies approximately 1.6 hectares of low-lying land historically characterized as coastal wetland. The area retains many of its natural hydrological features, including shallow groundwater, clay-rich soils, and proximity to tidal influences. During redevelopment in 2002, a system of swales and drains were dug to manage surface runoff and direct excess water toward the nearby Charlesworth Reserve and estuarine network. However, these features have become increasingly inefficient over time due to sedimentation, vegetation growth, and a lack of a gradient that limits outflow to the estuary. As a result, water frequently ponds within the nursery grounds, particularly following heavy rainfall or seasonal groundwater rise.

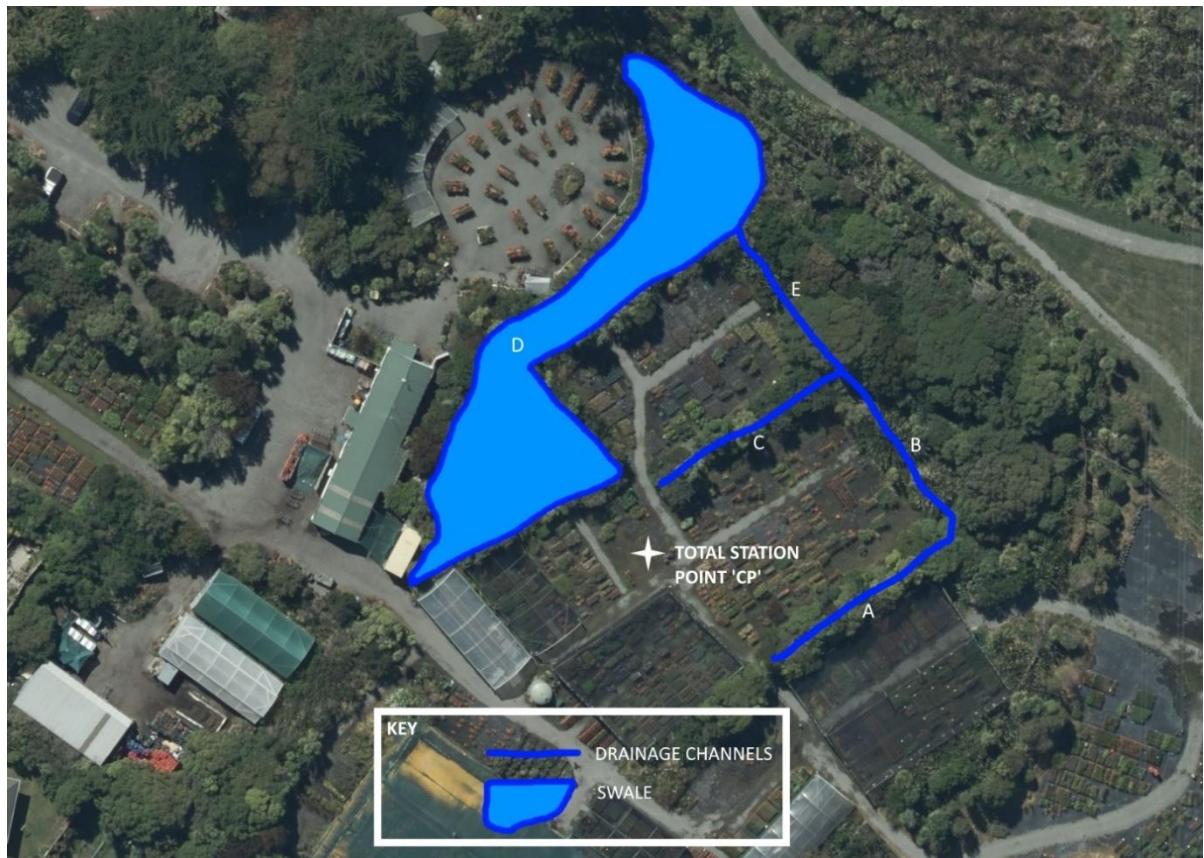
Figure 3: TotalStation base and drainage locations

Measurement of drainage channel profiles was first carried out using a Sokkia Total Station. A location was chosen so that a large proportion of the channels and swales were visible without moving the instrument. The chosen point 'CP' is shown in Figure 3 the channels to be measured, A, B, C and D. Setting up the instrument consisted of centering and levelling the tripod over a survey peg inserted in the ground at point 'CP'. An arbitrary coordinate system assigned with origin at X, Y, Z 100, 100, 100 was entered. A 'backsight' measurement was taken using a point on the top of the Fire Station training tower, adjacent to the site to the South.

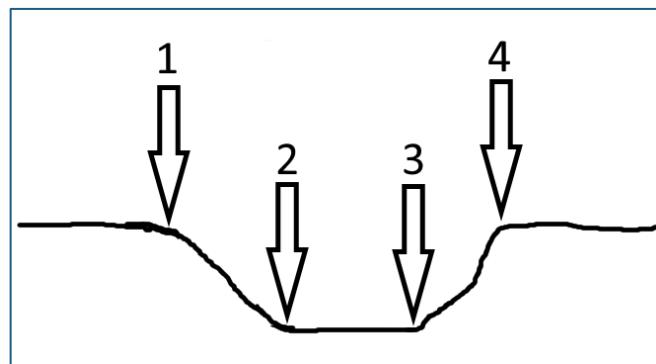
Figure 4: Measurement points on channel transect.

To capture a channel / swale profile, 4 points at each transect of the channel were recorded at approximately 5m intervals, see Figure 4. The first point was at the edge of the channel, the second at the lower end of the slope bank, the third at the lower end of the opposite bank, and the final point at the upper edge of the bank. Using this technique, the profiles of drainage channels and the swale were recorded.

Additional profiles were collected using a Leica GNSS Rover covering drainage channels 'D' and 'E', by the same method shown in Figure 4 and described above. The first point recorded

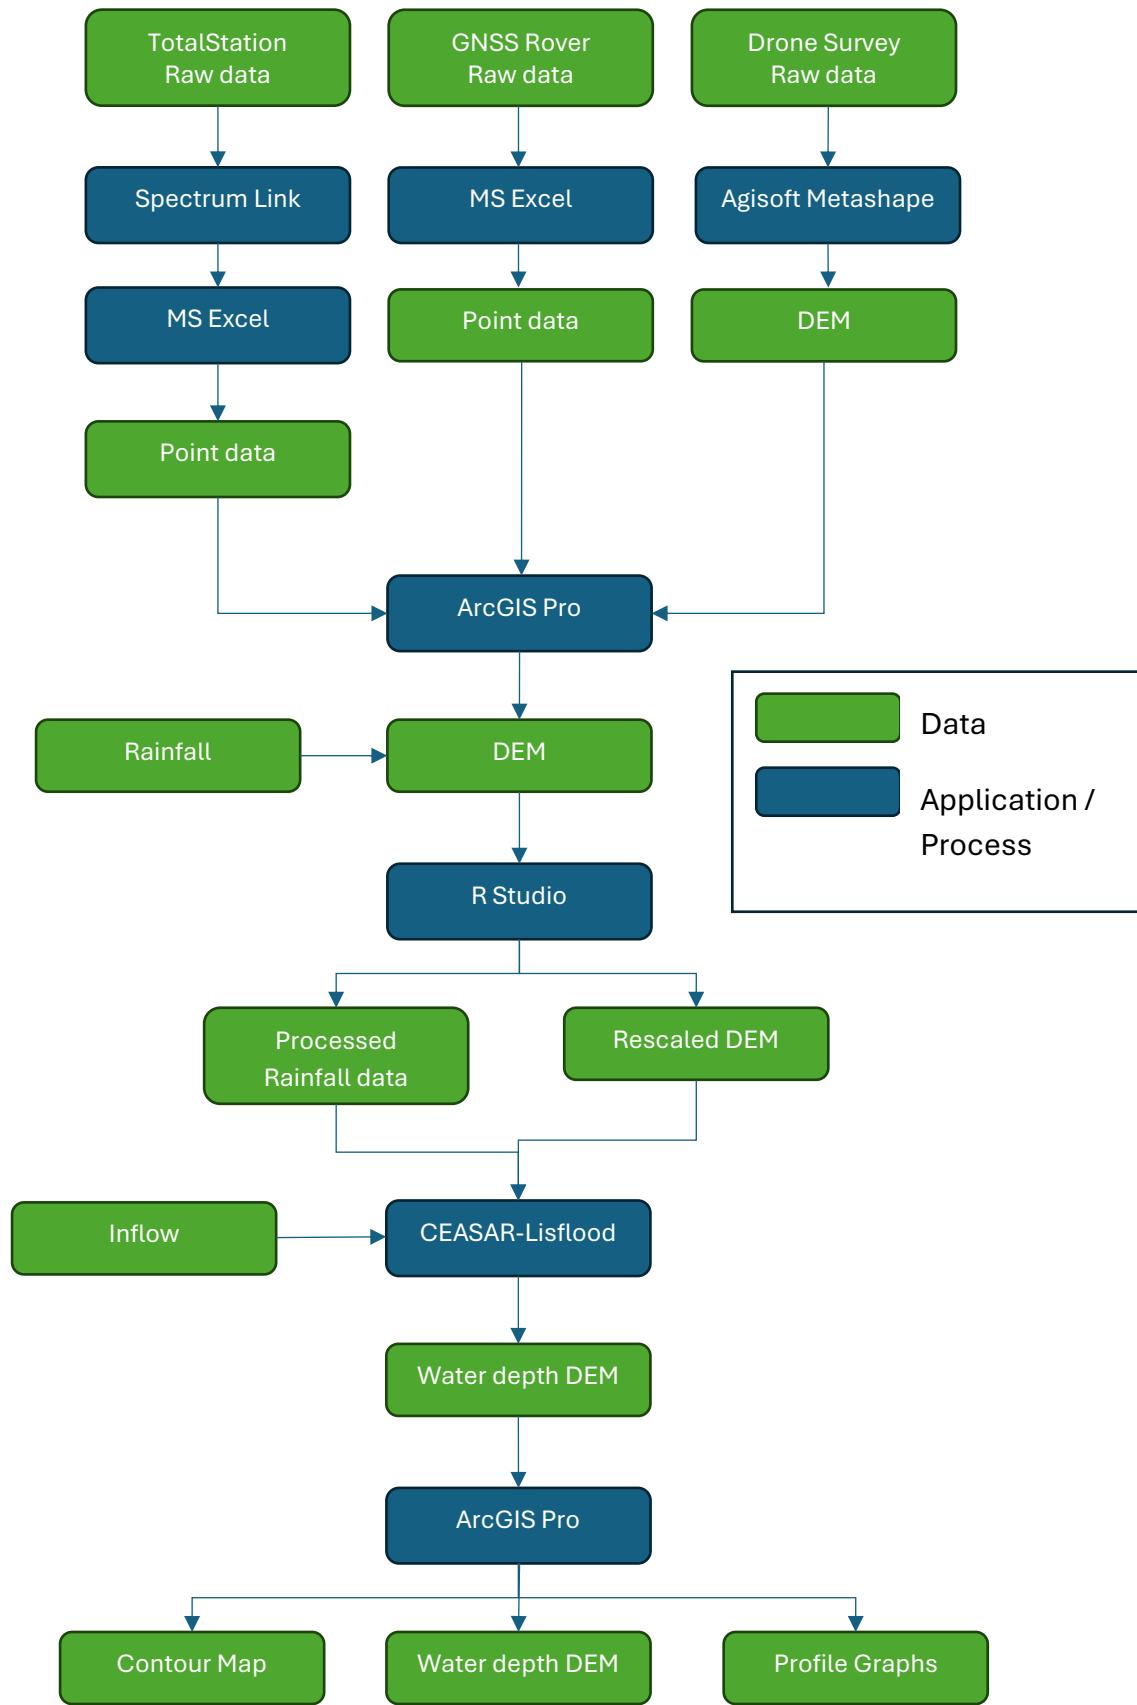
Figure 5: Methodology overview

Raw data collected from the field surveys and curated online sources was processed using proprietary and open-source software. The workflow from raw data collection to the final flood model output is shown in Figure 5. A detailed methodology is included in Appendix A.

An overview of the methodology is shown in Figure 5 and a full breakdown in Appendix A.

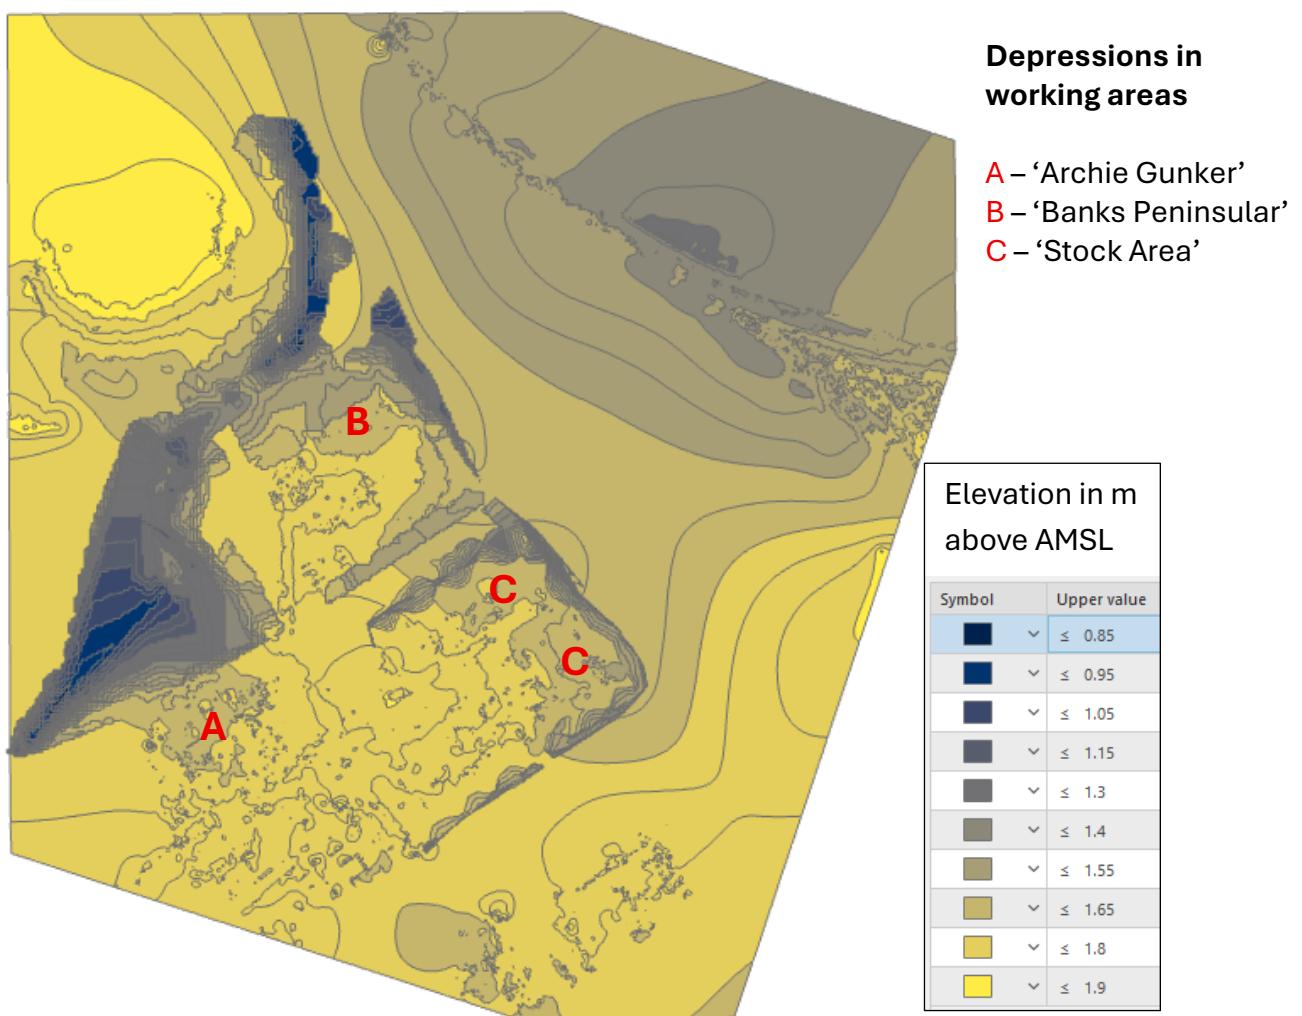
Figure 6: Study area contour map indicating depression in working areas.

The study area contour map in Figure 6 indicates where depressions in the working areas (up to 100mm) are present. These depressions are generally located on the periphery of the working areas as indicated. The other working areas have a flat, slightly elevated profile between 1.8m and 1.9m AMSL. Also apparent is the elevation decline towards the reserve to the NE, however not shown is the waterway that connects to the swale outlet to the waterway network in the reserve as this fell outside the study area.

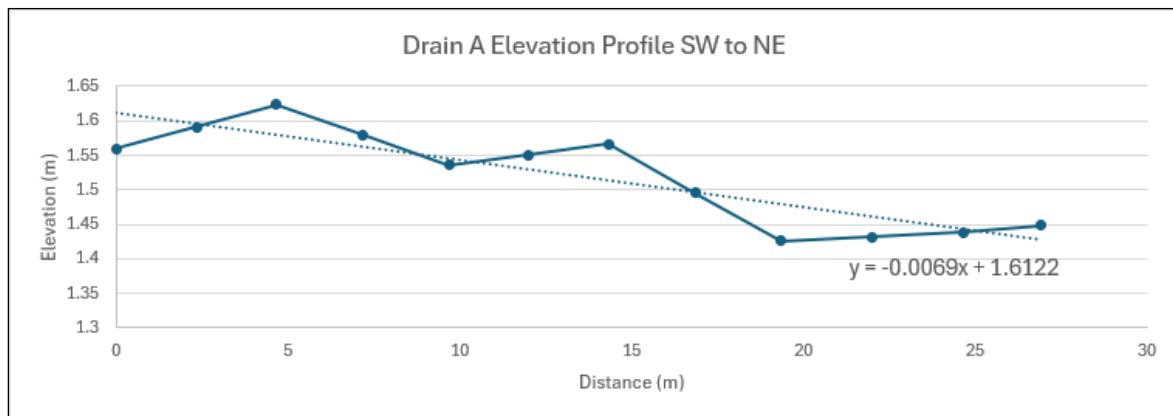
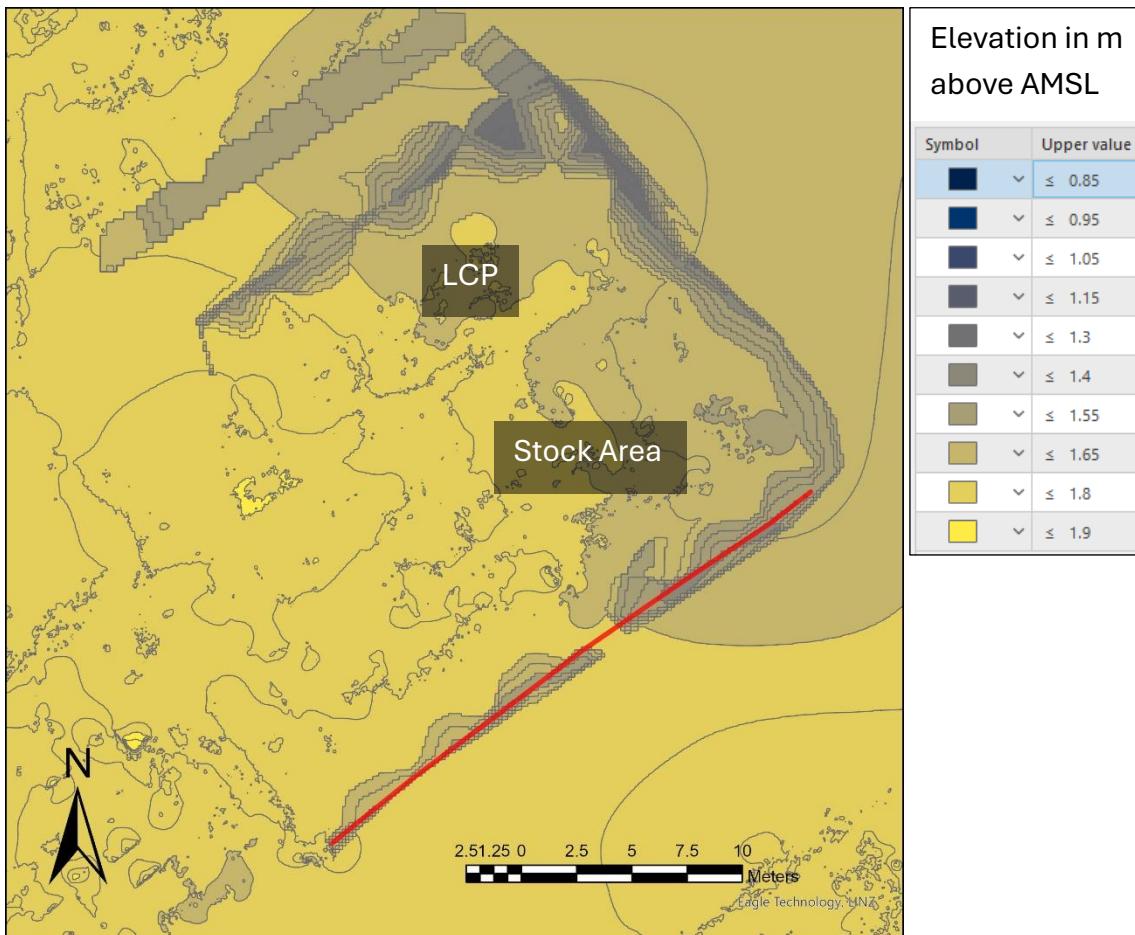
Figure 7: Drain A slope profile SW to NE

The average fall in elevation of Drain A is less than 1% over the ~27m length from SW to NE, see Figures 7 and 8. The slope is relatively linear with undulations superimposed on it. The elevation of the bottom of the drain is approximately 300 to 400mm lower than the working area it is designed to drain from.

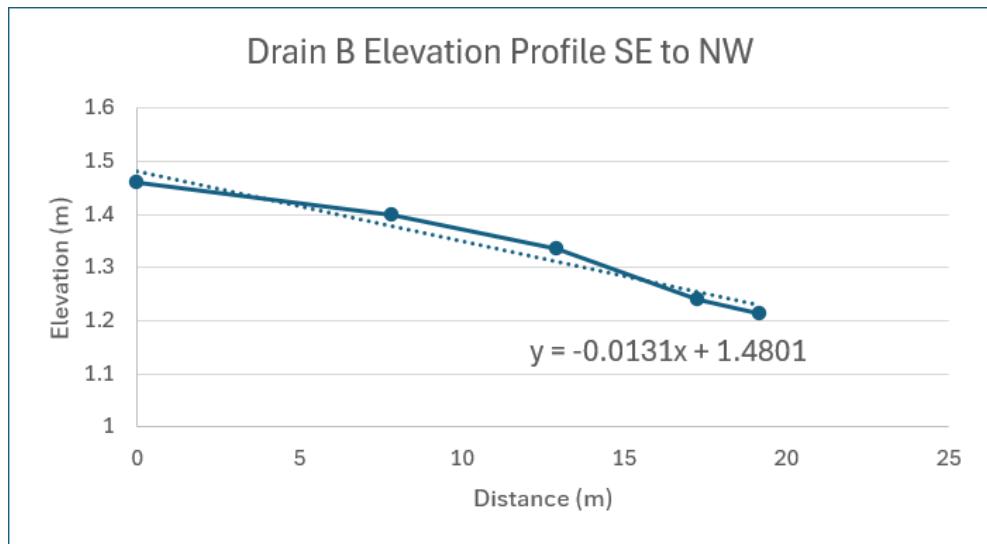
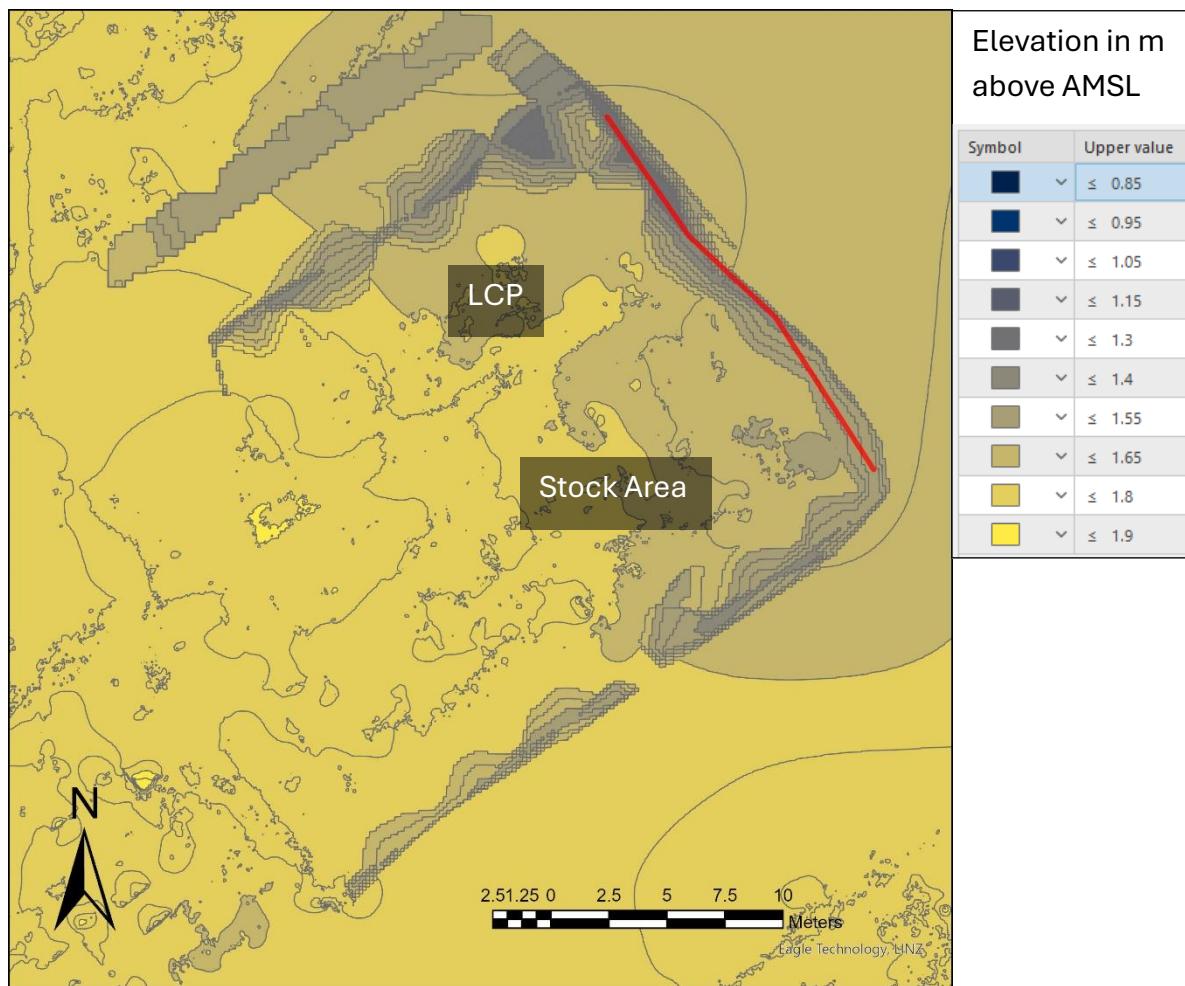
Figure 9: Drain B slope profile SE to NW

The average fall in elevation of Drain B is just over 1% over the ~19m length from SE to NW as shown in Figures 9 and 10. The slope is linear. The elevation of the bottom of the drain is approximately 200 to 450mm lower than the working area it is designed to drain from.

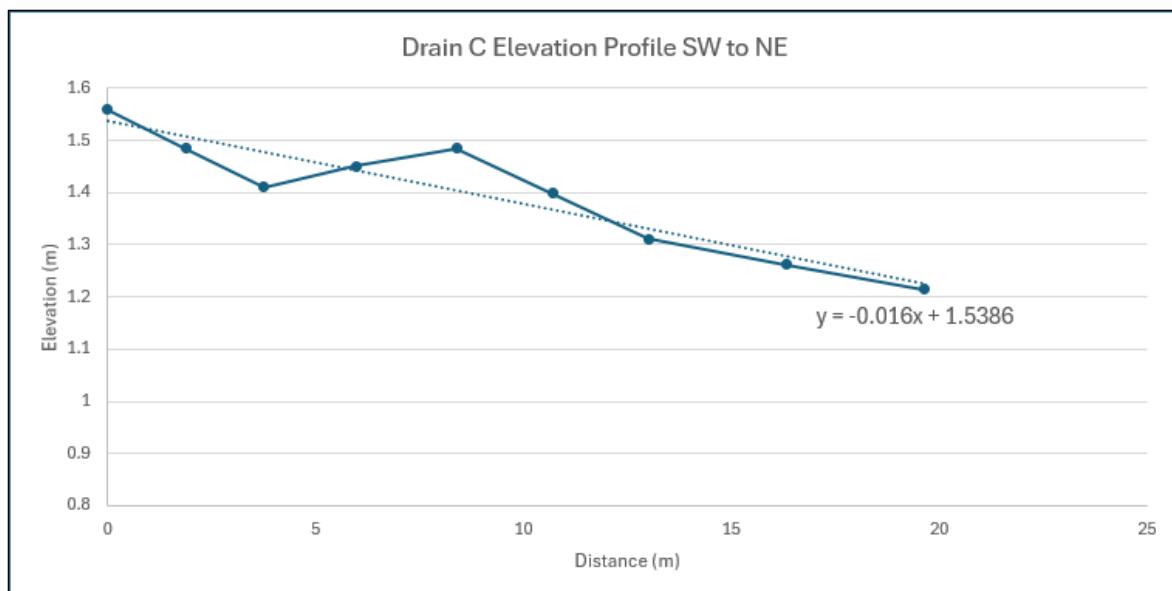
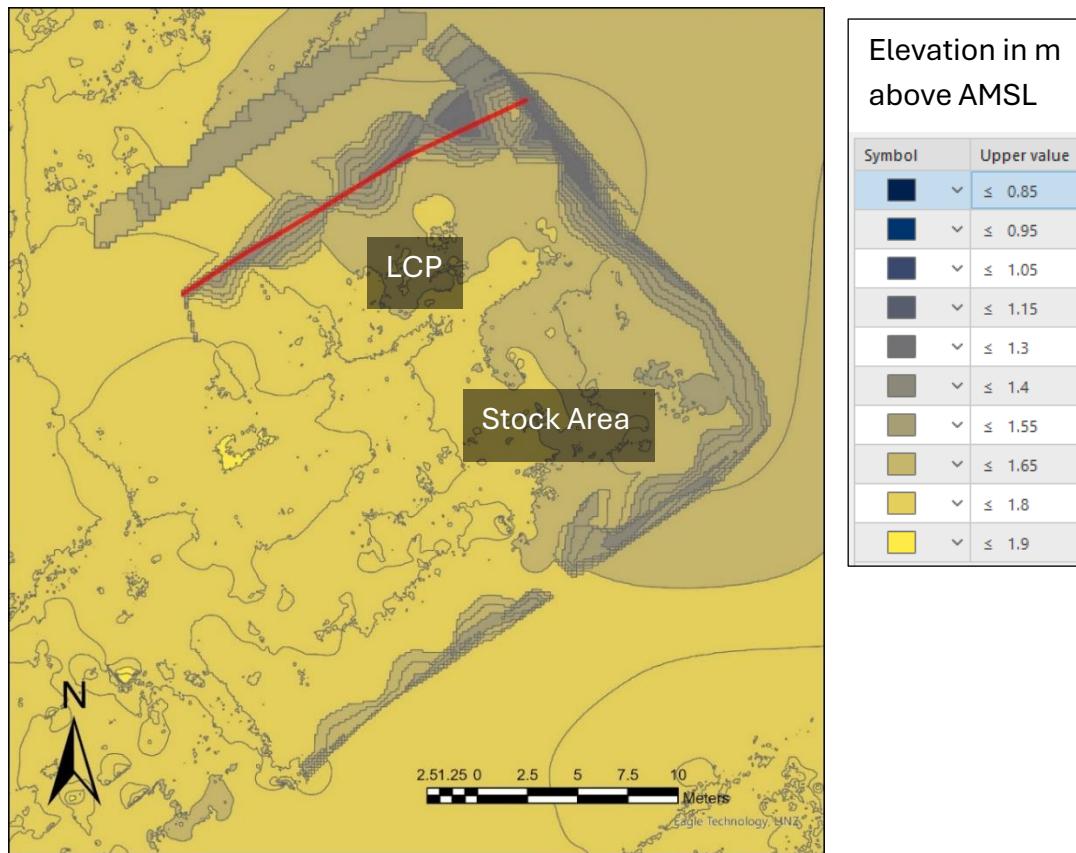
Figure 11: Drain C slope profile SW to NE

The average fall in elevation of Drain C is 1.6% over the ~20m length from SE to NW, see Figures 11 and 12. The slope is relatively linear. The elevation of the bottom of the drain is approximately 100 to 450mm lower than the working area it is designed to drain from.

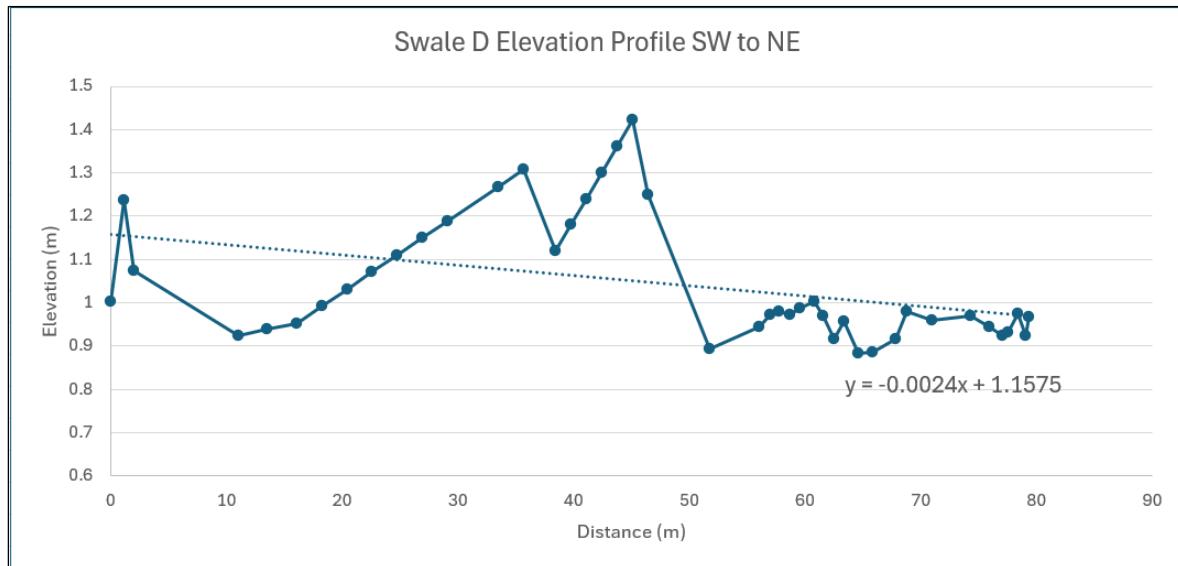
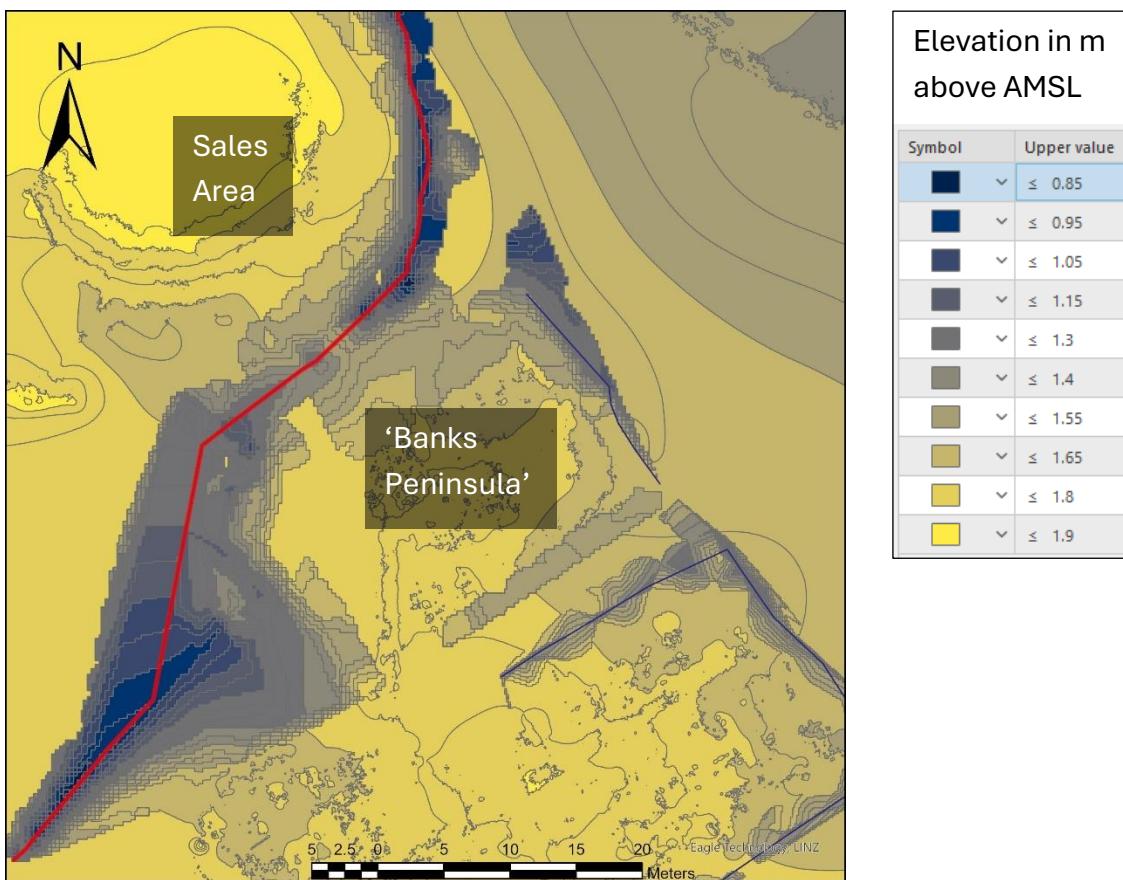
Figure 13: Swale D slope profile SW to NE

The average fall in elevation of Swale D is less than 1% over the ~85m length from SW to NE, see Figures 13 and 14. The slope has noticeable peaks and troughs throughout the length. The elevation of the bottom of the drain is approximately 100 to 500mm lower than the working areas it is designed to drain from.

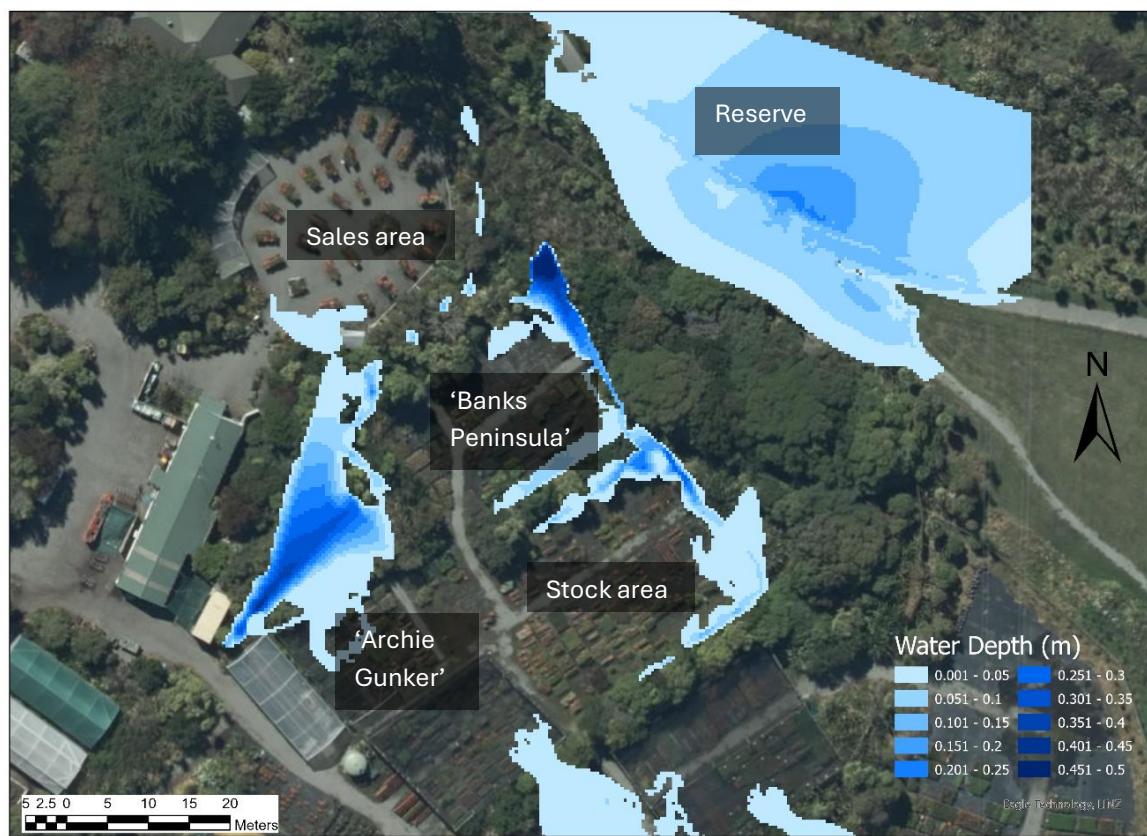
Figure 15: Flood model result after 60hr rainfall event, ARI 2 years, clay soil.

The output from the flood model is shown overlaid on the TFC site in Figure 15. The extensive flooded area to the NE is in the adjacent reserve which is outside the study area. Swale D has breached the SE and NW onto the ‘Archie Gunker’ and ‘Sales’ areas respectively. Drains A and B have breached at their intersection onto the ‘Stock’ area and adjacent stands of trees.

Swale D shows pools of water collected at the upper reaches, to the NE of the footbridge connecting the sales area to the ‘Banks peninsular’ area. This aligns with the swale profile in Figure 13 beyond the 50m mark where the elevation dips substantially then undulate for about 20m. Also, to note, although outside our study area, the flooding on the ‘McShady’, ‘Libertias’, Flaxes and Astelia’s’, ‘McBasil’ and ‘Outback’ areas have also been identified.

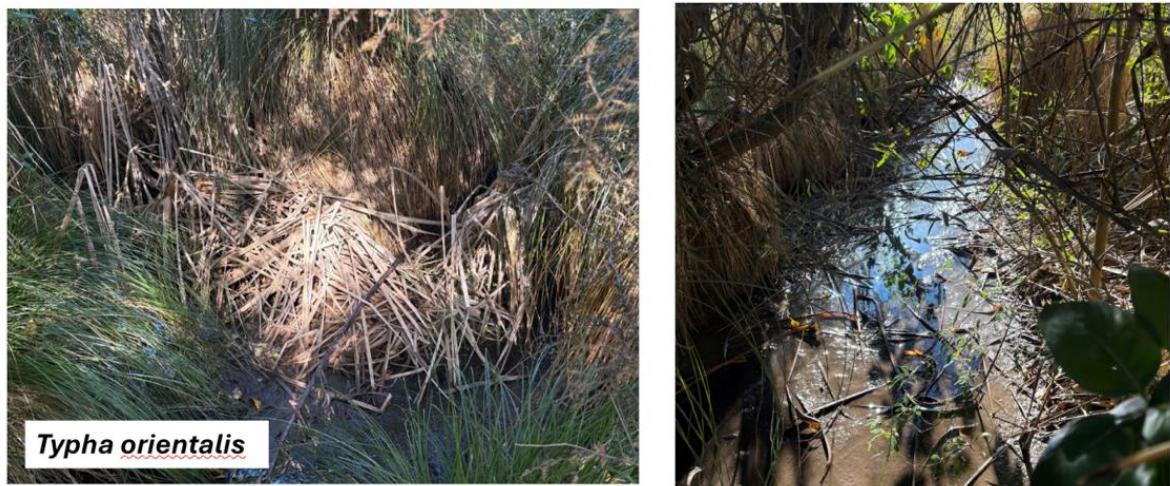
Field observations revealed that much of the drainage system is clogged with organic material and dense stands of *Typha orientalis* (bulrush), substantially reducing flow volume and velocity in the low-lying areas (Figure 16). Additionally, a significant portion of the 'Banks Peninsula' and 'Stock Area' zones experience recurrent flooding, largely due to surface depressions identified in Figure 6, that act as localized water traps. While *T.orientalis* contributes to wetland ecology, its dense biomass and root mats make it unsuitable for engineered swale systems, where unmanaged biomass can drastically reduce hydraulic efficiency (Chen et al., 2023).

Figure 16: The organic clog observed on site, that prohibits water movement.

Firstly, we recommend targeted removal of *T. orientalis* (Bulrush) from key flow paths, particularly where it obstructs swale outlets and low-elevation catchments. This should be done manually to minimize soil disturbance, with follow-up monitoring to prevent regrowth. Secondly, it is important to understand that as the site already contains a strong foundation of native wetland species, new vegetation planting should be minimal. Our research found *Phormium tenax* (Harakeke Flax) currently residing along the banks of the swale system. As this species is known a well-structured species for it's tolerance to saturated soils and structural role in erosion control (Sorrell et al., 2000), rather than introducing new plants, we recommend focusing on maintaining and managing this to optimize hydrological function.

In addition to ecological interventions, our research supports low-cost structural actions. Manual clearing of organic debris from swales is the most immediate and effective step to restore flow capacity, but this should be followed by improving connectivity between the swales and drains through digging or re-linking channels. Our drone survey revealed a fragmented system, and enhancing hydraulic continuity will allow water to move more efficiently across the site. The specific locations for organic matter removal are indicated in Figure 18Figure 18.

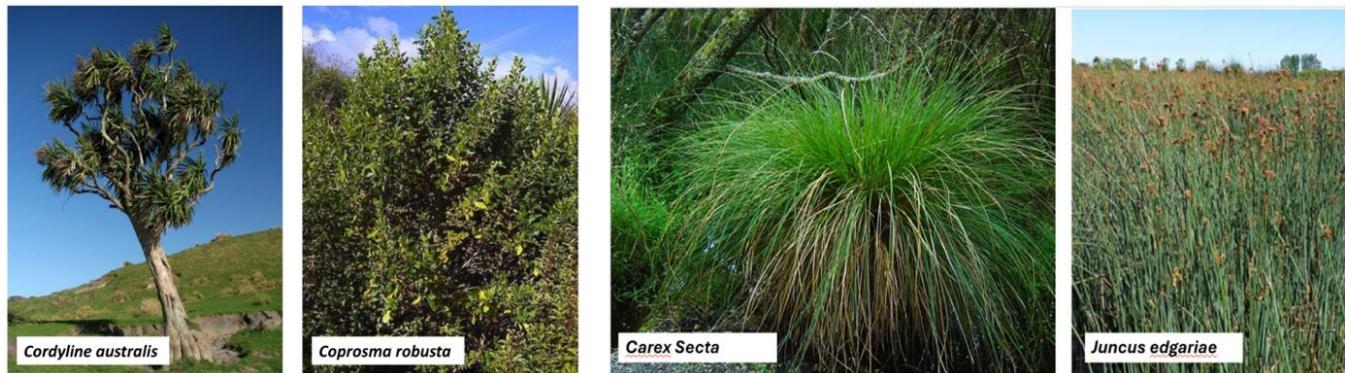
Figure 1716: Potential species that can be implemented on the TFC site.

Tanner et al, (1995) and Mitsch & Gosselink (2015) suggests suggest species such as *Carex secta* (Māorepo) and *Juncus edgarie* (Wīwī) (Figure 17) are well-adapted to saturated soils and offer low-litter profiles that resist matting. *C. secta* is especially valuable for its elevated tussock form, which raise the effective ground level and tolerate brackish water, making it a proactive choice for future salinity risks, and perfect for TFC's site (Clarkson & Peters, 2010; Waihora Ellesmere Trust, 2014). Provided *T. orientalis* (Bulrush) is manually removed and regrowth is monitored, *C. secta* and *J. edgarie* can successfully recolonize former bulrush zones without competition, restoring hydraulic connectivity and soil stability.

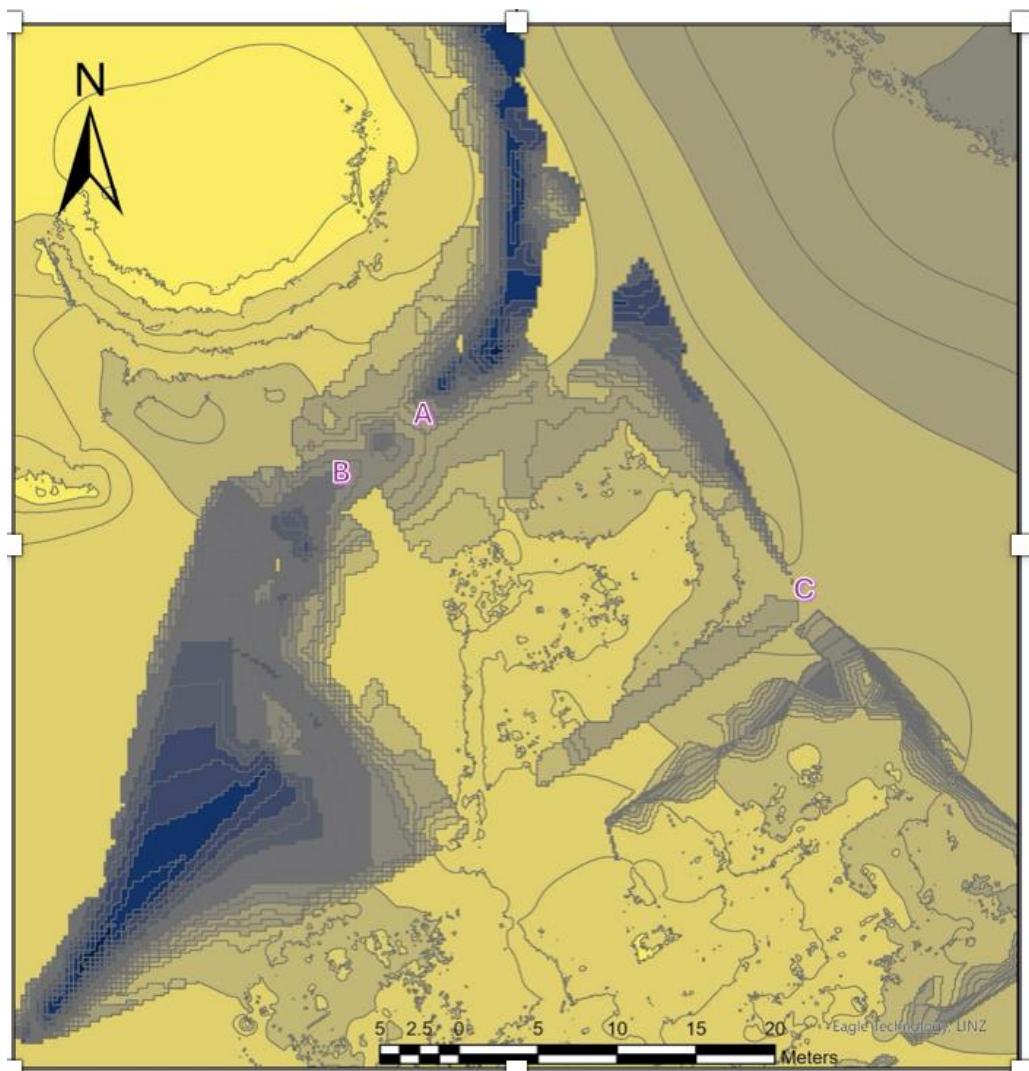
Figure 1817: Locations recommended for organic matter removal.

- A. Next to the footbridge on the North-East side.
- B. Next to the footbridge on the South-West side.
- C. The junction of drains B and C.

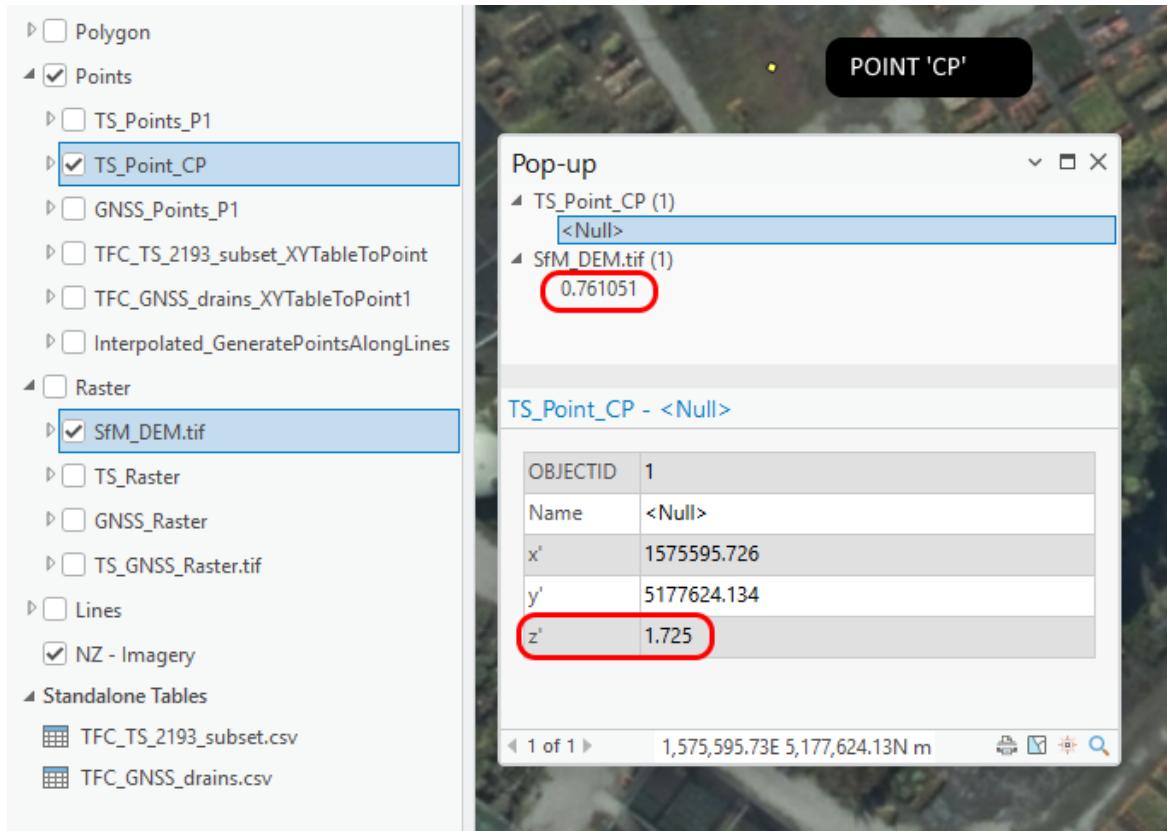
Figure A. 16 Elevation comparison between Structure from Motion and GNSS datasets at point 'CP'

The offset for the Structure from

Motion elevation is

$$1.725 - 0.761 = 0.964\text{m}$$

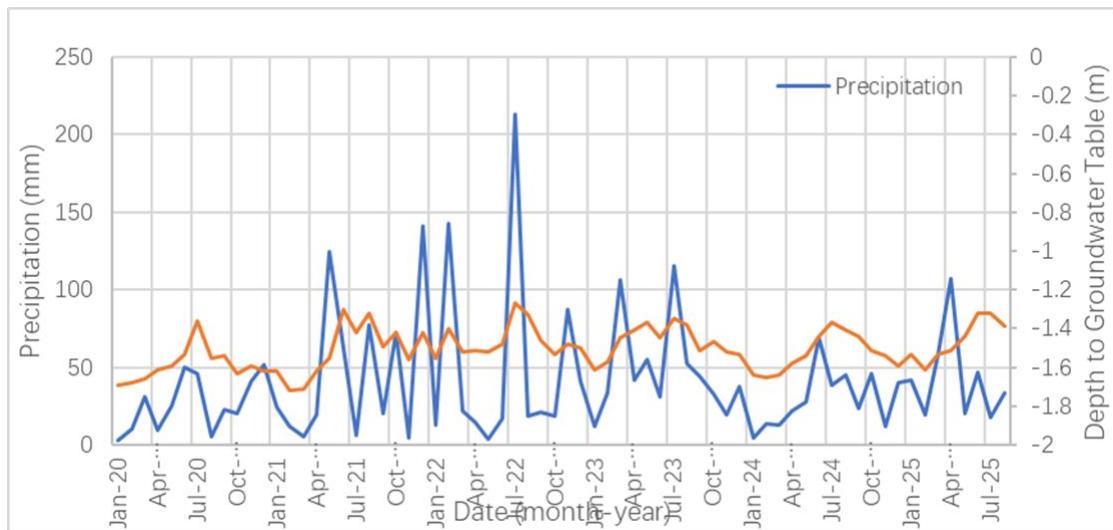
Figure C. 1 Monthly mean rainfall and groundwater table chart. (Environment Canterbury Regional Council & Earth Science New Zealand)

The slope relationship between precipitation/sea-level rise and groundwater table was obtained by using Excel. As shown in Figure 4, the correlation coefficient ( $R^2$ ) between monthly rainfall and the monthly groundwater table is approximately 0.25, indicating that rainfall accounts for 25% of the variation in groundwater levels. Moreover, the figure suggests that high precipitation can trigger a shallow groundwater level, especially during the rainy winter. Figure 5 shows that the  $R^2$  between annual sea-level rise and the annual groundwater table is approximately 0.54, indicating that sea-level rise explains 54% of the changes in the groundwater table. Nevertheless, it differs from the precipitation effect. High sea-level rise means a deep groundwater table. Water table data was downloaded from
