# **CoastSnap: Working with the Hurunui District Council**

**GEOG309: Research for Resilient Communities and Environments**

**Final Report**

**University of Canterbury  
17<sup>th</sup> October 2025**

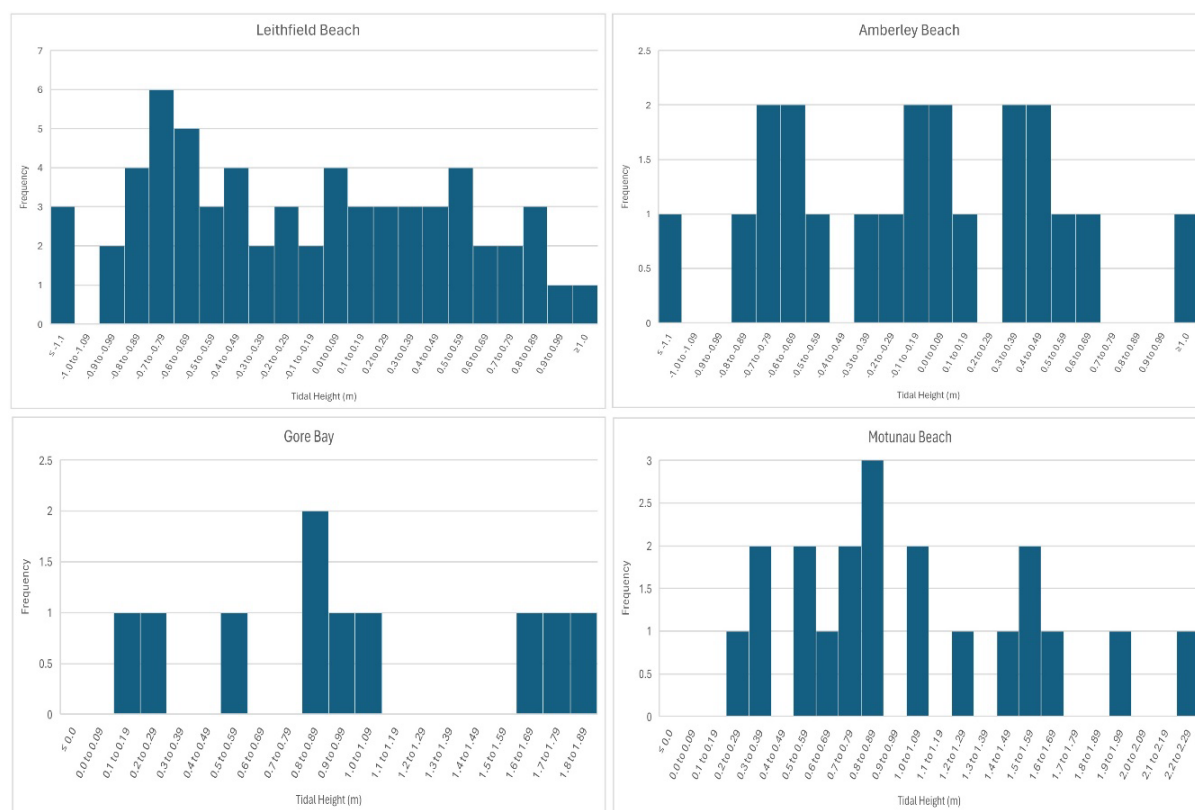
Figure 2: Histograms representing the times images are taken in relation to the tidal height at the four different beaches, Leithfield, Amberley, Motunau and Gore Bay. Each beach has different tidal heights that are mainly captured, often missing the highest highs and lowest lows. Data sourced from (National Institute of Water and Atmospheric Research [NIWA], n.d.).

The frequency of CoastSnap photos captured in relation to the tidal phase is clustered around different tidal heights (*Figure 1*). Many images are captured at approximately mid-tide, failing to capture the beaches at tidal extremes. Amberley Beach exhibited a moderate frequency of photos submitted, with three distinct peaks in photo frequency corresponding to tidal heights of around -0.6m to -0.79m, -0.1 to 0m, and 0.3m to 0.49m, indicating a limited tidal range was captured. In contrast, both Motunau Beach and Gore Bay have a very low frequency of images, as indicated by the significant gaps on both plots. This restricts the analysis of long-term shoreline change, but may indicate short-term synoptic events, depending on the timing of the images captured.

Leithfield Beach recorded the highest frequency of CoastSnap photo submissions with 62 photos. Although this site had a greater number of images, both high and low tidal extremes remained underrepresented (Figure 2), and no significant erosional event was captured. Despite having only 29 photo submissions, Motunau Beach successfully captured an erosional event associated with a storm, likely due to the timing of when the photographs were taken. Ensuring scientific rigor and consistency overtime is crucial to ensuring the utility of the data collected so that events such as this can be captured (Soriano-González, Sánchez-García, & González-Villanueva, 2024).

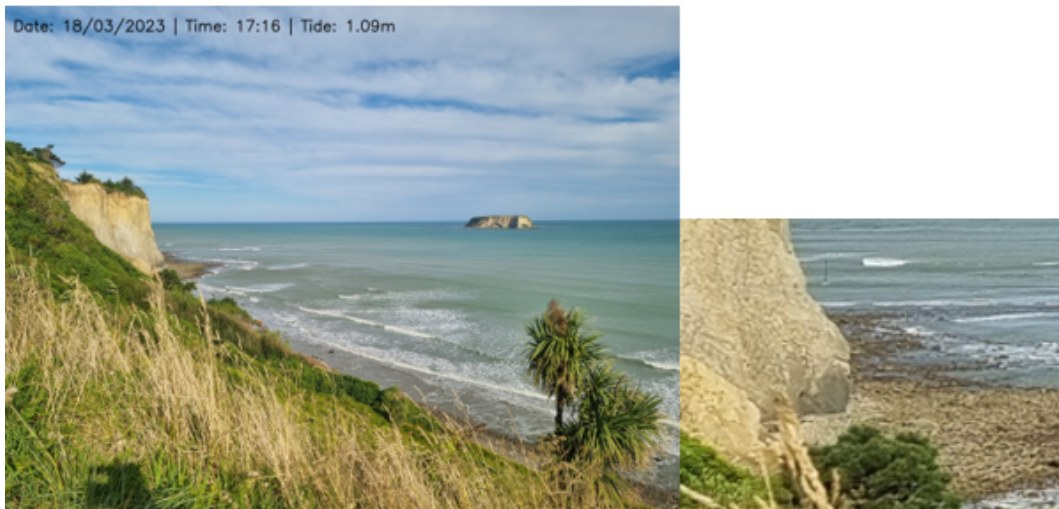
*Figure 3: Cliff toe at Motunau Beach before erosion, photographed on 18/03/2023.*

Analysing erosion through the images provided was done through observing an extreme weather event. Through Identifying, the event at Motunau (*Figure 2 and 3*), we were able to compare the identified storm to wave, swell, and weather station data, observing the severity of the storm system. Weather system data was obtained from Rangiora EWS (early warning system), Christchurch backup AERO AWS (automatic weather station), and Amberly reserve road (National Institute of Water and Atmospheric Research [NIWA], n.d.). Significant wave height data was obtained through the Pacific Islands Ocean Observing System ([PacIOOS], n.d). The data obtained was then plotted and displayed in tables on excel, displaying the intensity of the storm event and its erosional capabilities along Motunau.

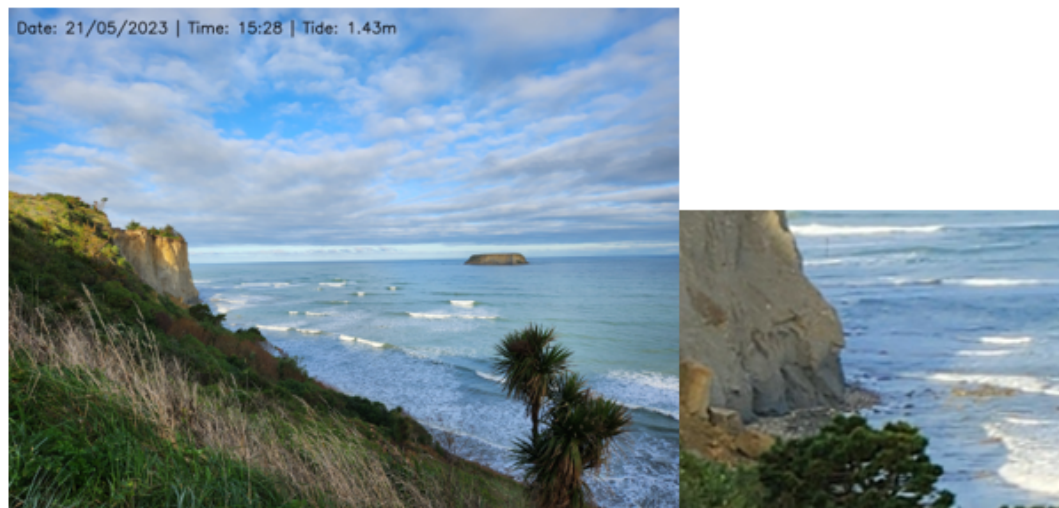
*Figure 4: Progression of cliff toe erosion at Motunau Beach on 21/05/2023, showing the initial formation of an overhang at the cliff base.*

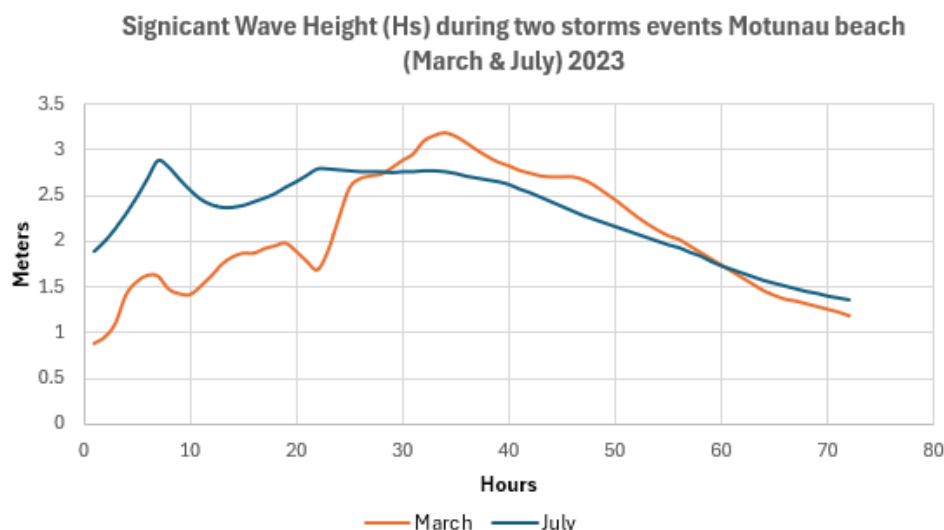
Figure 7: Comparison of the two-storm events, March and July, at Motunau Beach over three days. Data sourced from (Pacific Islands Ocean Observing System [PacIOOS], n.d.).

Table 1: Peak significant wave height in Motunau Beach in the storm events in March and July 2023. The peak significant wave height in the March storm was 3.18 m compared to the July storm, which peaked at 2.79 m. Data sourced from (Pacific Islands Ocean Observing System [PacIOOS], n.d.).

When examining the wider Christchurch region, it is evident that large swells coincide with stormy conditions. By linking the wave data to the weather data, we observed that strong gusts and heavy rainfall were present on the days of high swells. These storm events contributed to the destabilisation of the cliff and its eventual collapse over the six months. Due to the lack of images, we can't pinpoint the exact event that caused the collapse; however, it allows us to see how a significant event may have contributed to it.

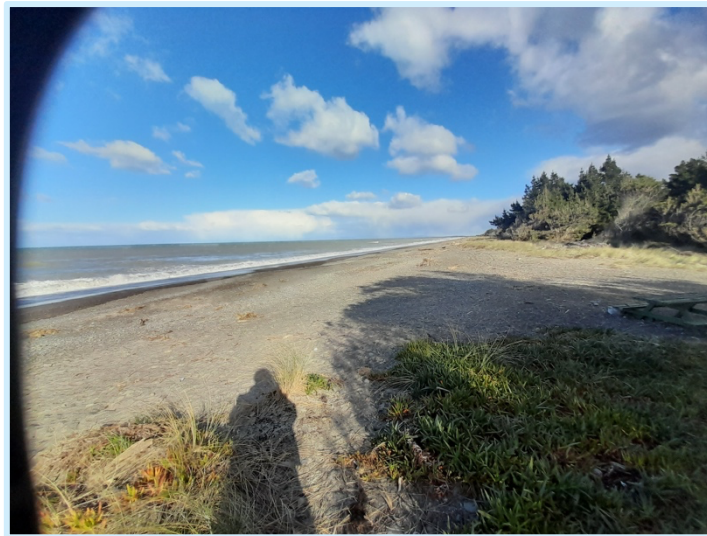
Figure 8: An example of an unusable image taken at Leithfield Beach using the CoastSnap stand. The edges of the image are distorted, compromising data quality.

Figure 8 presents an example from Leithfield Beach, where the CoastSnap image is unusable due to distorted edges, compromising the data quality. In contrast, Figure 9 displays an ideal stand position at Manly Beach, Australia. This stand has five fixed structures (corners of solar panels, the edge of a building, and stairs), which serve as reliable ground control points for accurate image alignment (Figure 9). Additionally, the elevated positioning of the stand enhances the ability to monitor coastline changes by capturing a balanced view of both the beach and ocean. Figure 10, also from Leithfield Beach, highlights another problematic stand placement, where the absence of fixed structures for ground control points limits the image's usefulness for analysis and interpretation. The vegetation present in the image cannot serve as a reliable reference due to its dynamic nature (marked in dashed red lines in Figure 10).

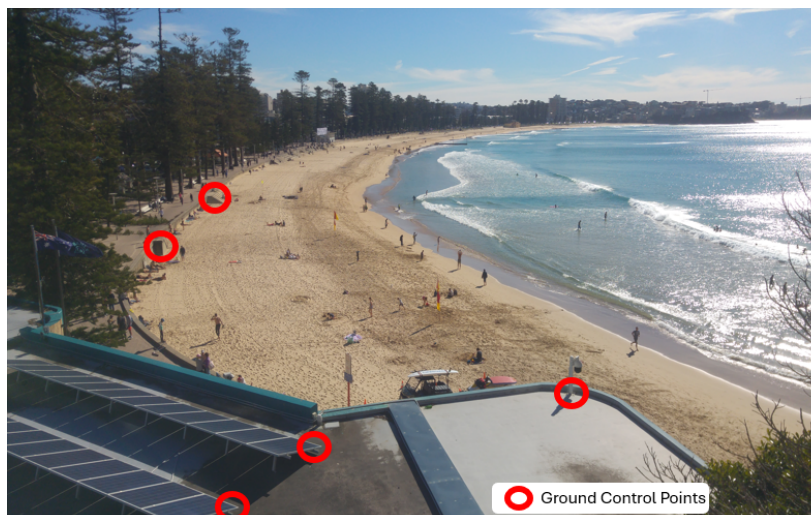
Figure 9: This image is an example of a good CoastSnap stands position. This stand is located at Manly Beach in Australia. Five fixed structures (marked in red circles) that won't change over time can be used for ground control points (used for image alignment). Adapted from the example CoastSnap image from the CoastSnap Starter Toolkit (Harley, n.d.).

An aim of this project was to work out how the CoastSnap sites on the Hurunui coast could be improved so that deeper analysis of coastal change could be completed. To do this, drawbacks of the positions of the current CoastSnap sites and framing of the current images were identified. This was done by identifying whether the ideal CoastSnap site characteristics, which were explained by Mitchell Harley in a CoastSnap YouTube video, were present at the Hurunui Sites (Harley, 2020). The Hurunui Sites were also compared to a site in Manly, Australia which contains all the ideal CoastSnap site characteristics and has been successfully analysed (*Figure 9*).

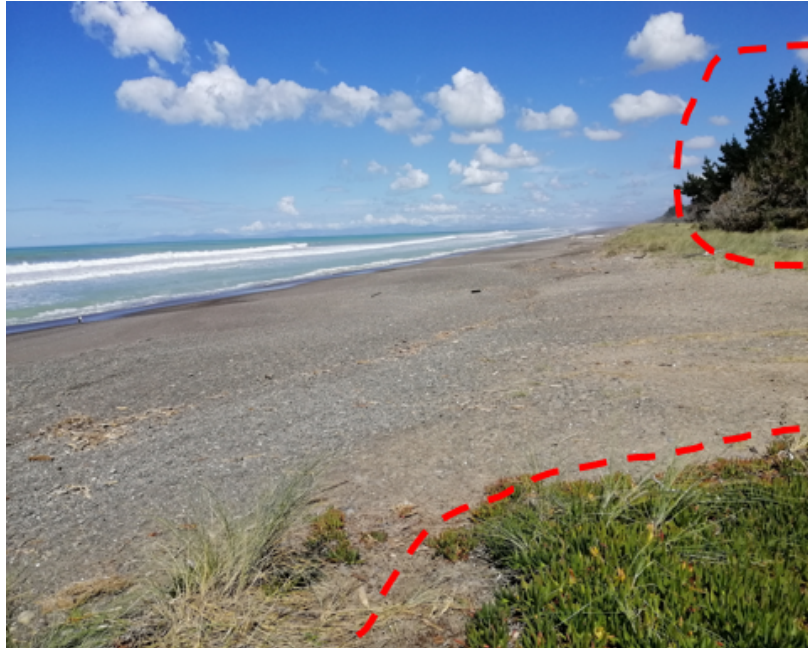
*Figure 10: This image was taken at the CoastSnap stand at Leithfield Beach. This image is missing key characteristics to align with the current CoastSnap analysis. There are no fixed structures in this image to use as ground control points, limiting its usefulness for analysis. The dashed red lines indicate the areas of vegetation; however, they cannot be used as ground control points, as vegetation grows and changes over time.*

These requirements advise the placement of the stands to look along the coastline, portraying the shoreline or coast of interest in the centre of the image, ensure the stand is elevated to portray the entire width of the beach, and include stable points to allow ground control points (GCPs) to be taken (Harley, 2020). *Figure 9* is an example of a CoastSnap stands image from Manly Australia. The Image portrays, all requirements, as well as multiple GCPs. Through meeting these requirements, scientists/researchers can create a quantitative data record of two-dimensional shoreline positions or other relevant features (Harley et al. 2022). When analysing Manly's example compared to the stands/locations along Hurunui, we observed multiple differences causing limitations within the images presented. These are seen in *Figure*

10. The shoreline is not centred, the stands are not elevated, and solid objects are not visible nor available for further analysis within the figure. Leithfield, Amberley and Motunau all shared this lack of requirements, causing difficulty when analysing how each coastline has changed over the three-year implementation period.

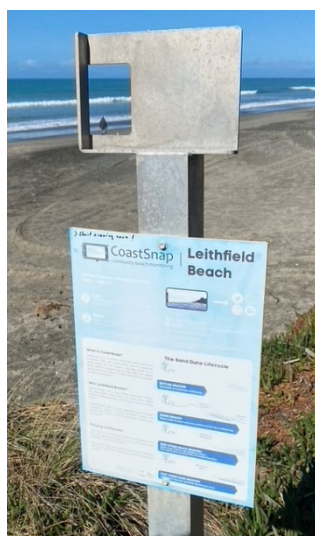
*Figure 11: This image was taken at Leithfield Beach. It shows the current CoastSnap stand. The sign has been visibly damaged by likely sun exposure, which has caused the sign to fade in colour. The sign is difficult to read and contains lengthy instructions. The phone placement area is unclear.*

The current signage at Leithfield Beach is visibly damaged by sun exposure, causing fading and making it difficult to read (*Figure 11*). The instructions are lengthy, and the phone placement area lacks clear orientation guidance. In contrast, *Figure 12* presents two new sign designs with more explicit instructions, images for phone orientation, and an educational component about the dune life cycle and coastal erosion. The new signs also include a QR code, allowing users to receive an automated email with instructions on how to upload their images, which will be sent directly to the Hurunui District Council. This creates clarity on where and at what times images are taken, furthermore simplifying the process of sorting images.

*Figure 11* illustrates the current, faded CoastSnap signage, while *Figure 12* presents the proposed redesigned version. Bright colours are strategically used to attract viewer attention and evoke a sense of engagement or fun, which is crucial for factors including increasing public participation (Awad, et al., 2025). High contrast colour schemes such as dark text on a light background or vice versa has been used to enhance legibility and improve comprehension, particularly in outdoor environments where lighting conditions can vary (Hall & Hanna, 2004). This aesthetic approach not only supports effective communication but also enhances long-term durability of the signage despite UV-induced fading from sunlight. In contrast, the current CoastSnap signs have proven to be ineffective and unreadable after only three years of exposure to the environment, as shown in *Figure 11*. The proposed redesign prioritises
