Supporting Nature: Rocky Outcrop Soil Stabilisation in Mt Vernon Park

GEOG309: Research for Resilient Environments and Communities

17th October 2025

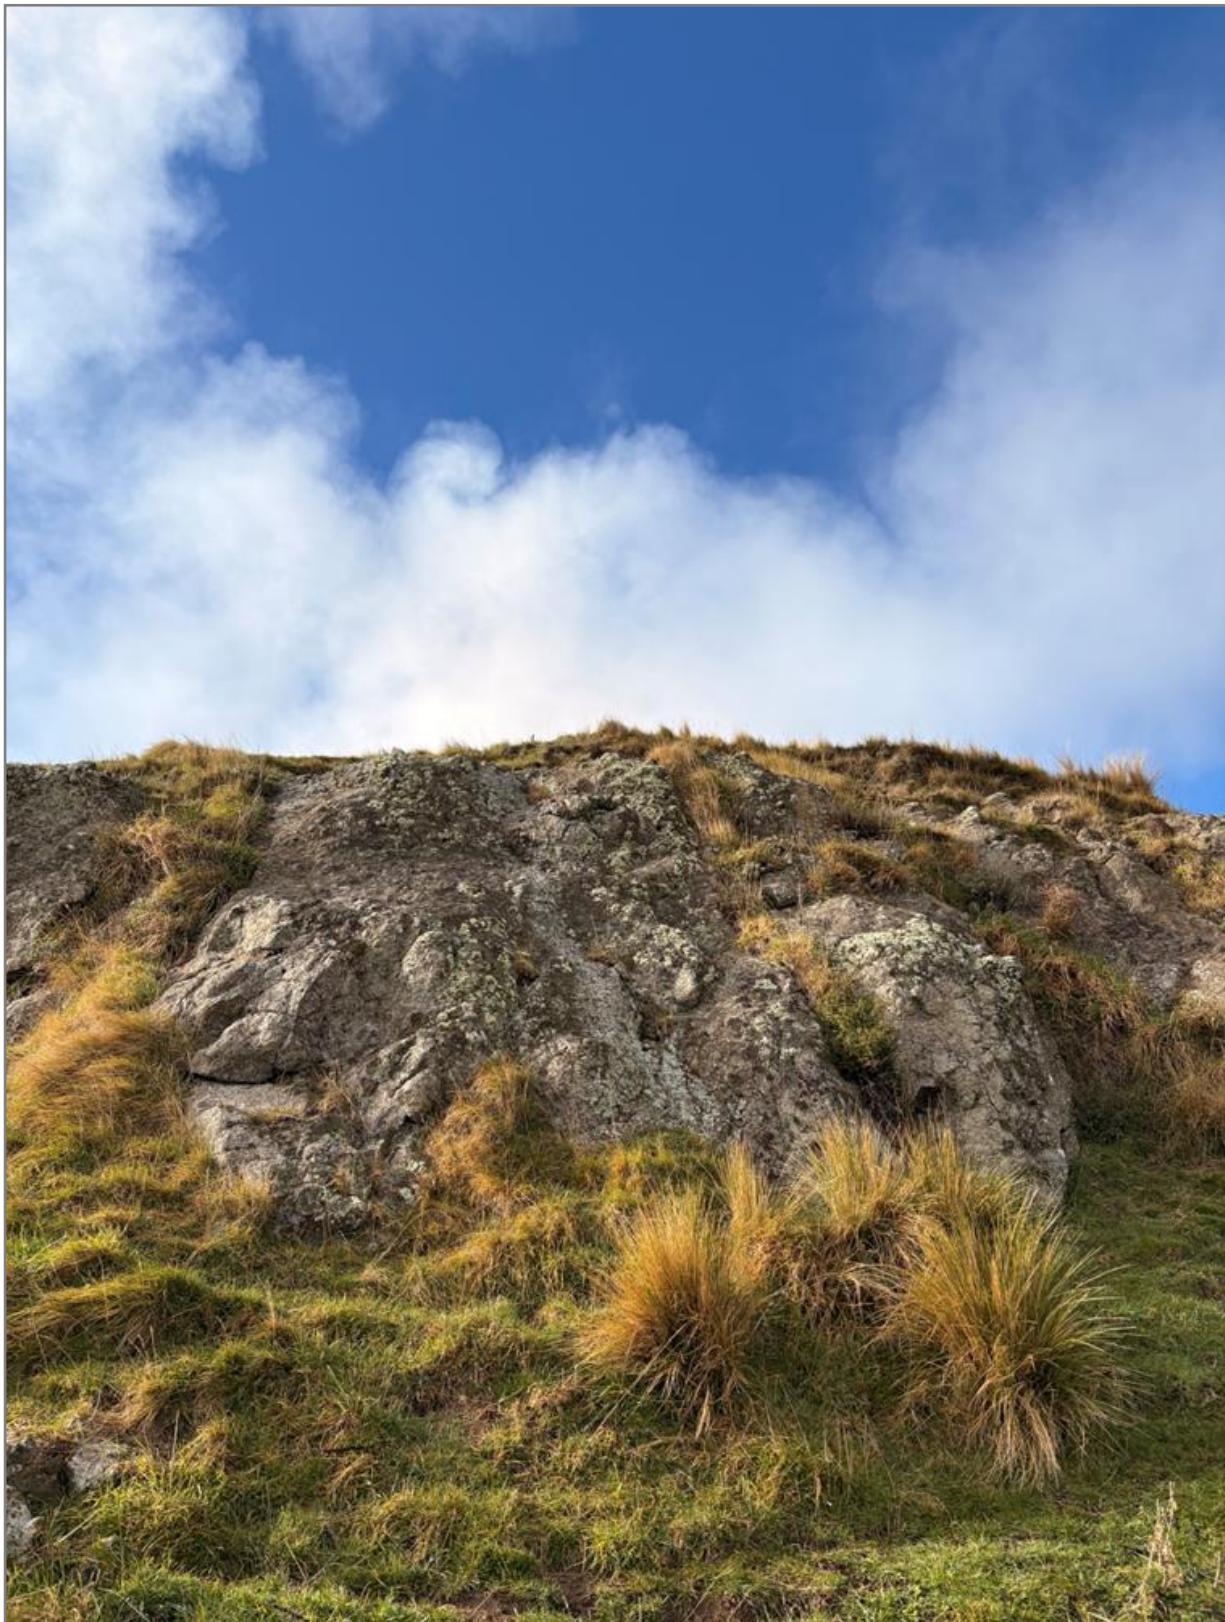
Figure 1: The selected rocky outcrop for in-situ testing in MVP (Ferguson, 2025).

During the in-situ field testing, it was hoped that mitigation products would slow water flow across the outcrop, therefore, reducing soil erosion. To select a suitable outcrop for testing, surface flow patterns and places of natural soil accumulation were considered (Figure 1C). A rocky outcrop in MVP with areas of soil erosion was selected (Figure 2).

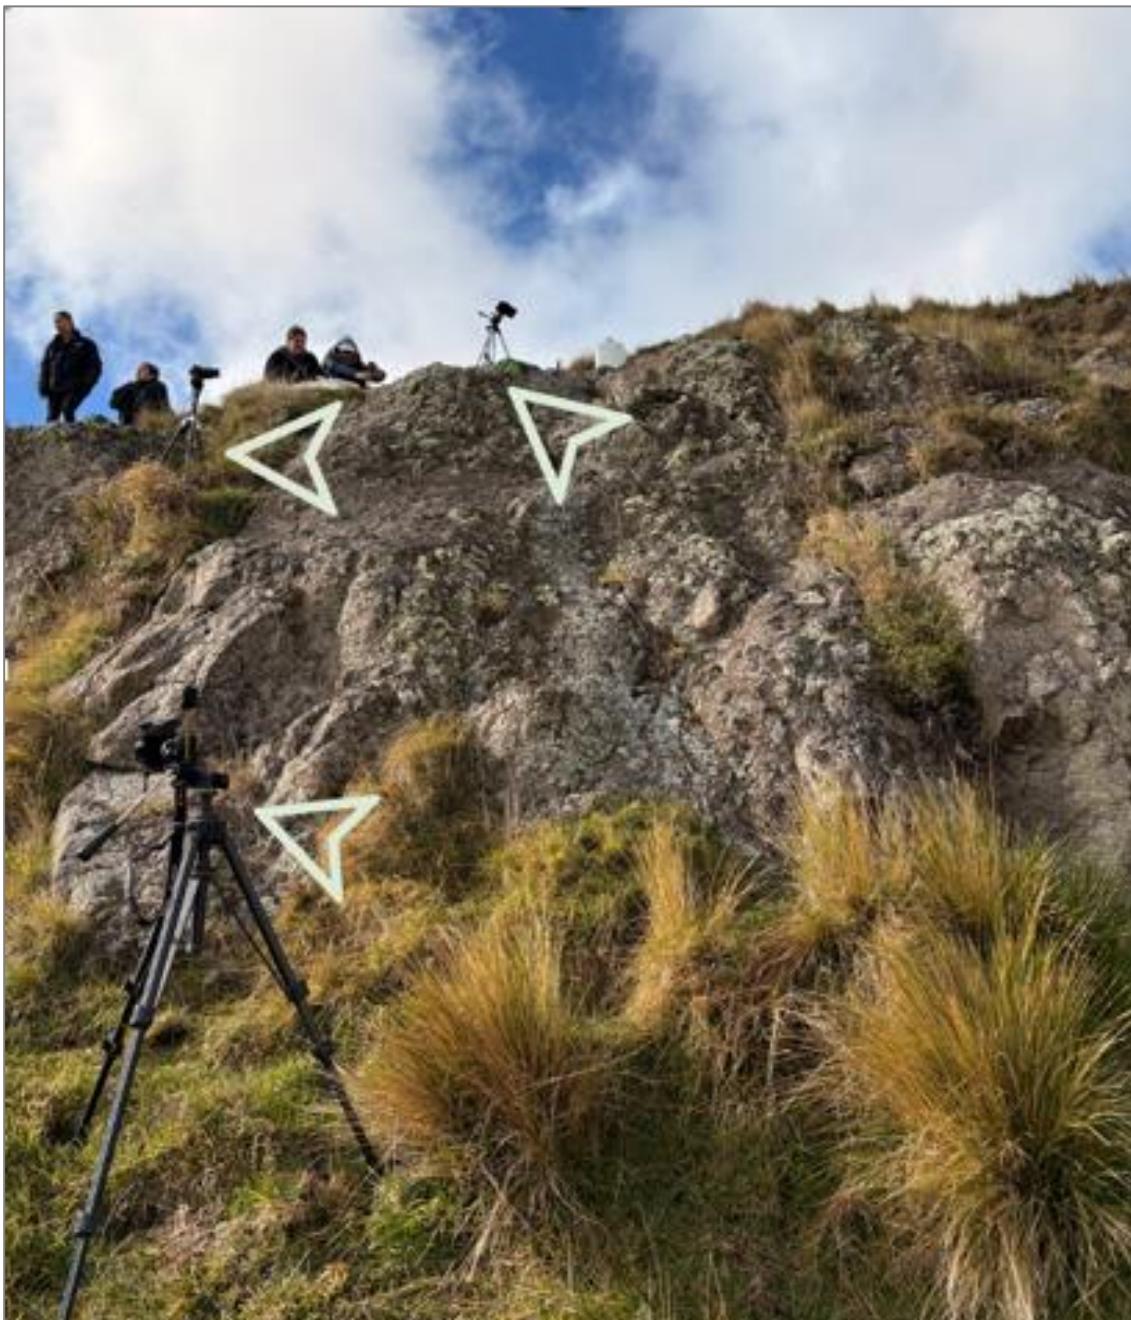
Figure 3: Annotated photo showing the position of 3 cameras on the chosen rocky outcrop during field testing (Bridgman, 2025).

Site set-up included positioning cameras, adding markers on the outcrop, setting up the water dispersal method, and positioning the soil loss mitigation methods when required. Three cameras were positioned across the outcrop to record water dispersal and flow down the outcrop (Figure 3).

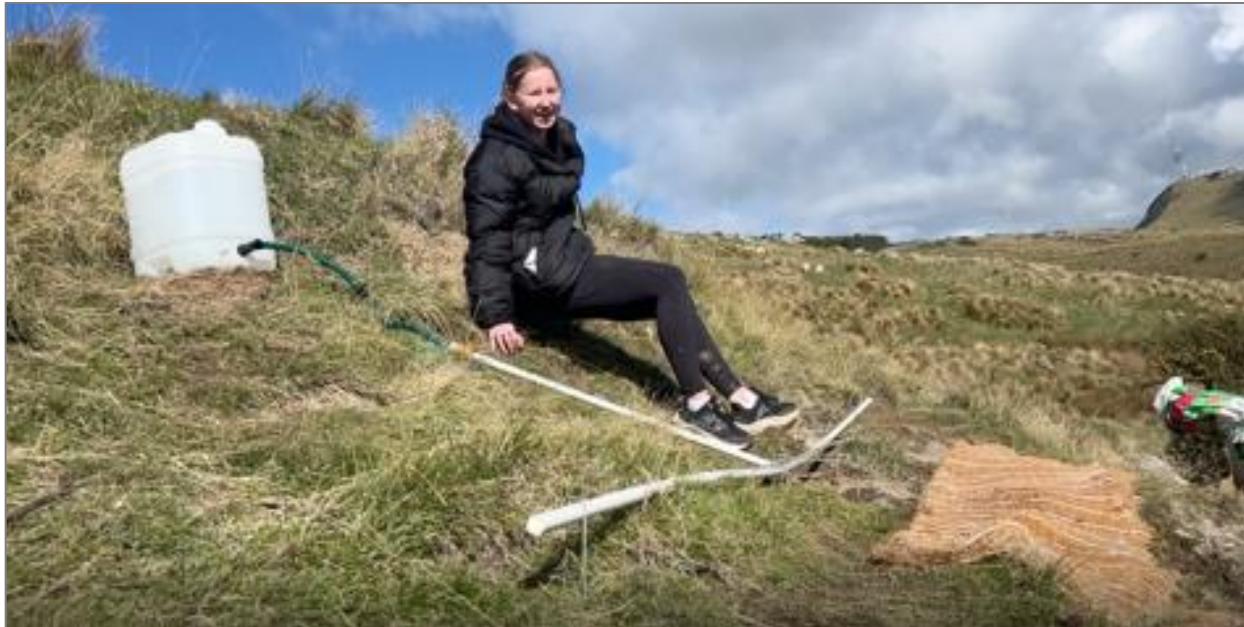
Figure 2: Camera angle of the camera positioned on the top of the outcrop (Bridgman, 2025).

A camera at the top of the outcrop recorded water dispersal (Figure 4), a second camera recorded a bird's eye view of a ledge where potting mix was added (Figure 5), and a third camera positioned at the bottom of the outcrop recorded soil and water movement (Figure 6).

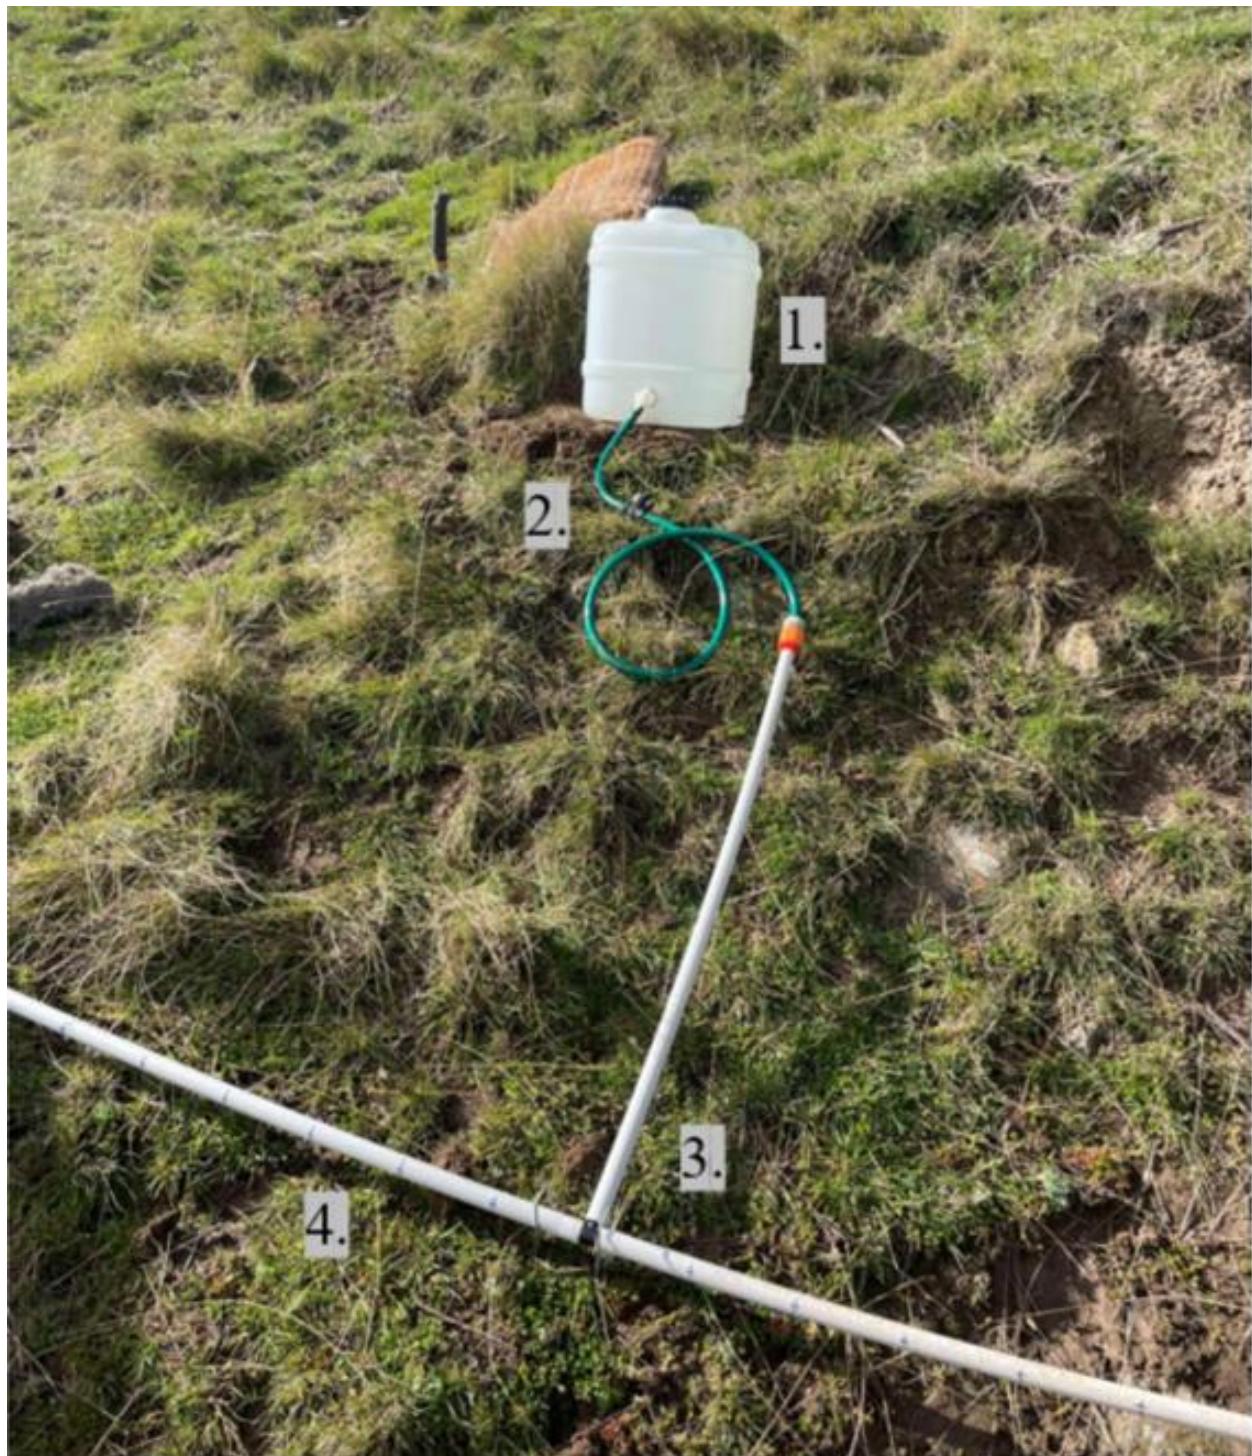
Figure 6: The water dispersal method. 1 = 20L water tank, 2 = hose connection, 3 = 4m spread tubing, 4= holes drilled 10cm apart spanning 1m (Bridgman, 2025).

The water dispersal method consisted of a T-shaped PVC pipe with holes to release water (Figure 8). This pipe was attached to a hose, which was connected to a raised 20L water tank. This set-up remained consistent across all tests. Research showed different in-situ water dispersal methods, including a water tank with a small tap (Orlandini et al., 2012), natural rainfall in set up plots (Li et al., 2023) and using portable rainfall stimulators with 1-8 nozzles (Neumann et al., 2022). Funding constraints exclude methods like Neumann et al. (2022) that require a water tanker and decent water pressure. Funding and lab constraints eliminated the possibility of set-up plots; therefore, natural rainfall did not allow for an accurate measurement of soil loss. The addition of a hose and a horizontal perforated pipe mimics natural runoff more closely than a tap and can be assembled at MVP. Before being used in MVP, it was tested on the UC campus to ensure it worked.

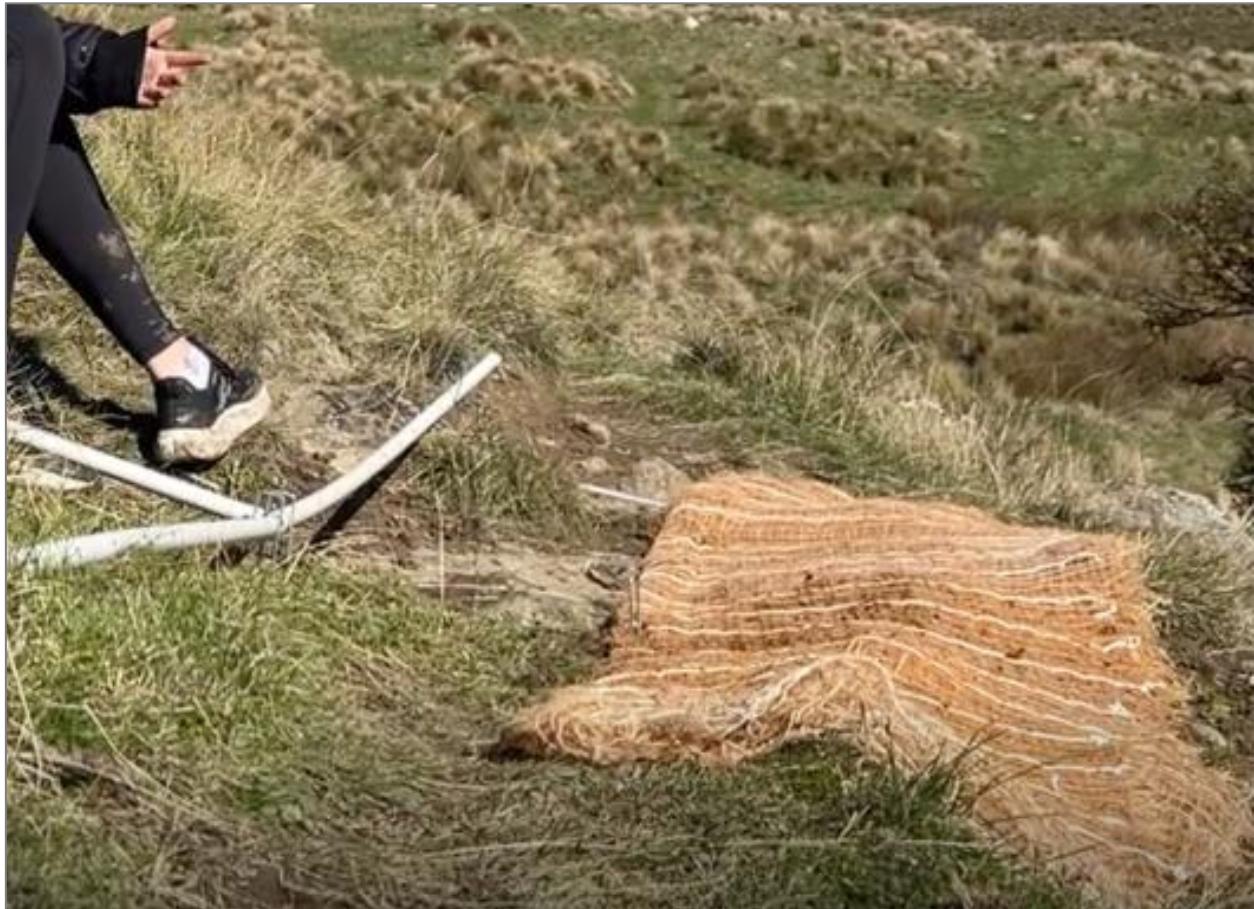
Figure 7: Folded Coir Blanket (Bridgman, 2025).

Evidence shows that biodegradable geotextiles made from natural fibres, particularly jute, can reduce soil loss by up to 99% and significantly lower runoff rates (Kalivová et al., 2016). Sutherland and Ziegler (2007) found that coir-based rolled logs improved infiltration, delayed runoff initiation and reduced sediment yield, with random-fibre blankets outperforming open-weave designs. These results guided our decision to use a geotextile blanket made from coir

matting, folded over itself, as one of our mitigation methods as an immediate erosion control measure.

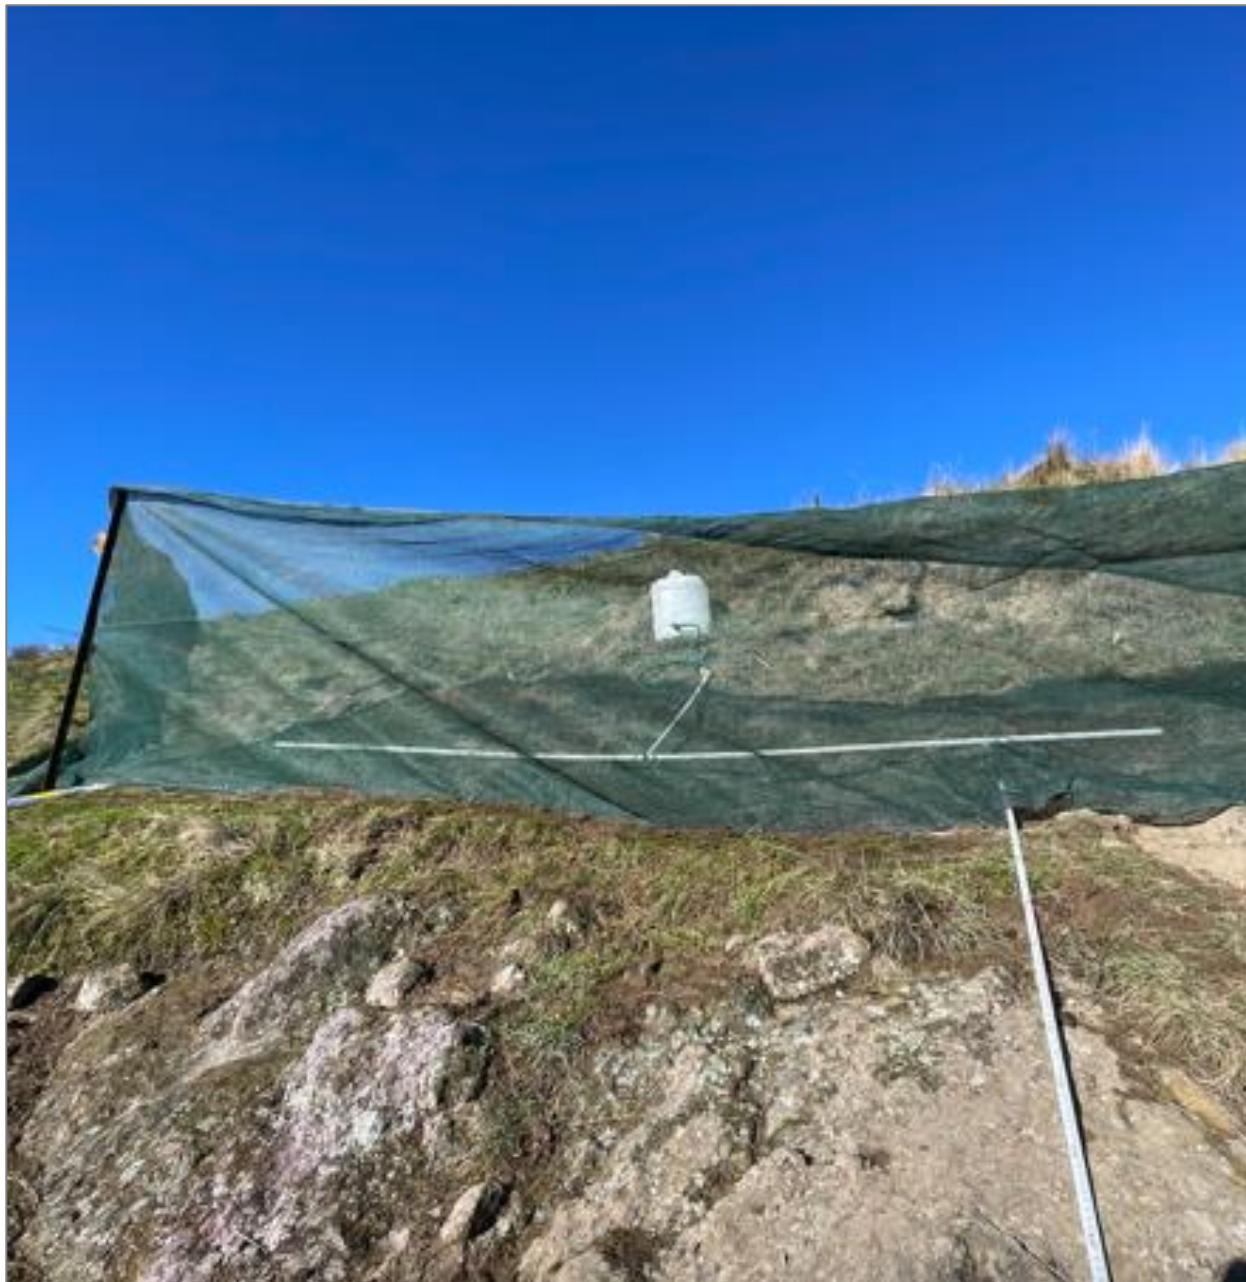
Figure 9: Silt fence attached to the outcrop by 2 posts and inserted into a dug-out trench where possible (Bridgman, 2025).

Evidence shows reinforced and properly trenched silt fences perform significantly better at reducing sediment loss and preventing water underflow compared to standard installations (Bugg et al., 2017). Based on this, a silt fence was installed using a trenching method to enhance stability and prevent underflow during high-intensity precipitation events. This could not be achieved in areas of exposed volcanic rock, as no surface was available to trench.

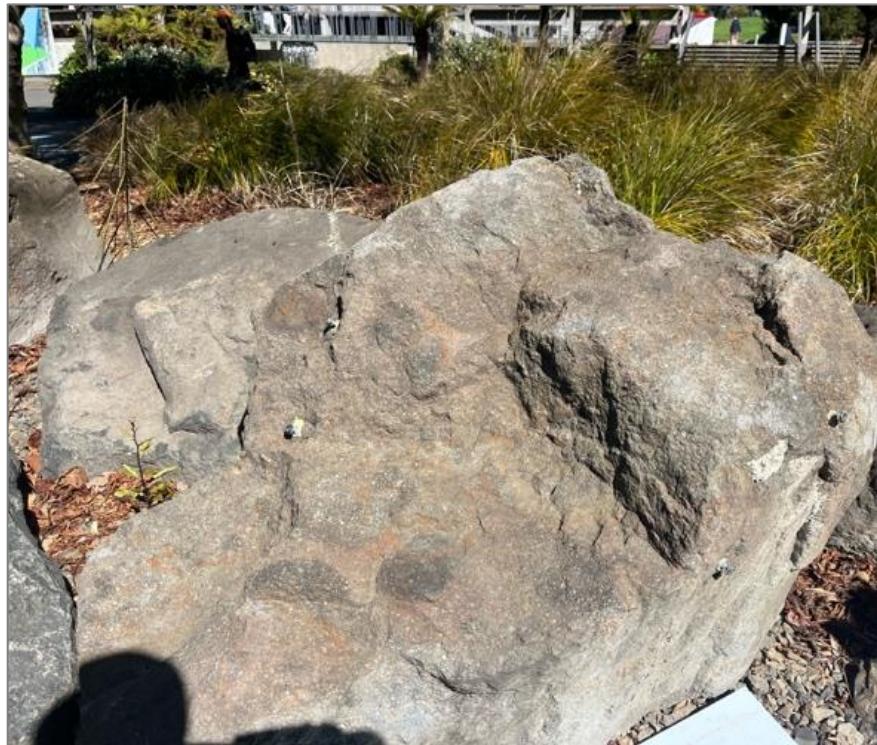
Figure 17. The rock in UC's Geology Garden that was deemed successful for testing (Ferguson, 2025).

Rock in UC's Geology Garden had suitable characteristics, including a ledge where potting mix could be applied (Figure 18). The rock had a morphology where water flow would be directed to the middle of the rock (Figure 18; see Figure 1C) and of volcanic origin from the Port Hills, so it is directly comparable to in-situ outcrop testing.

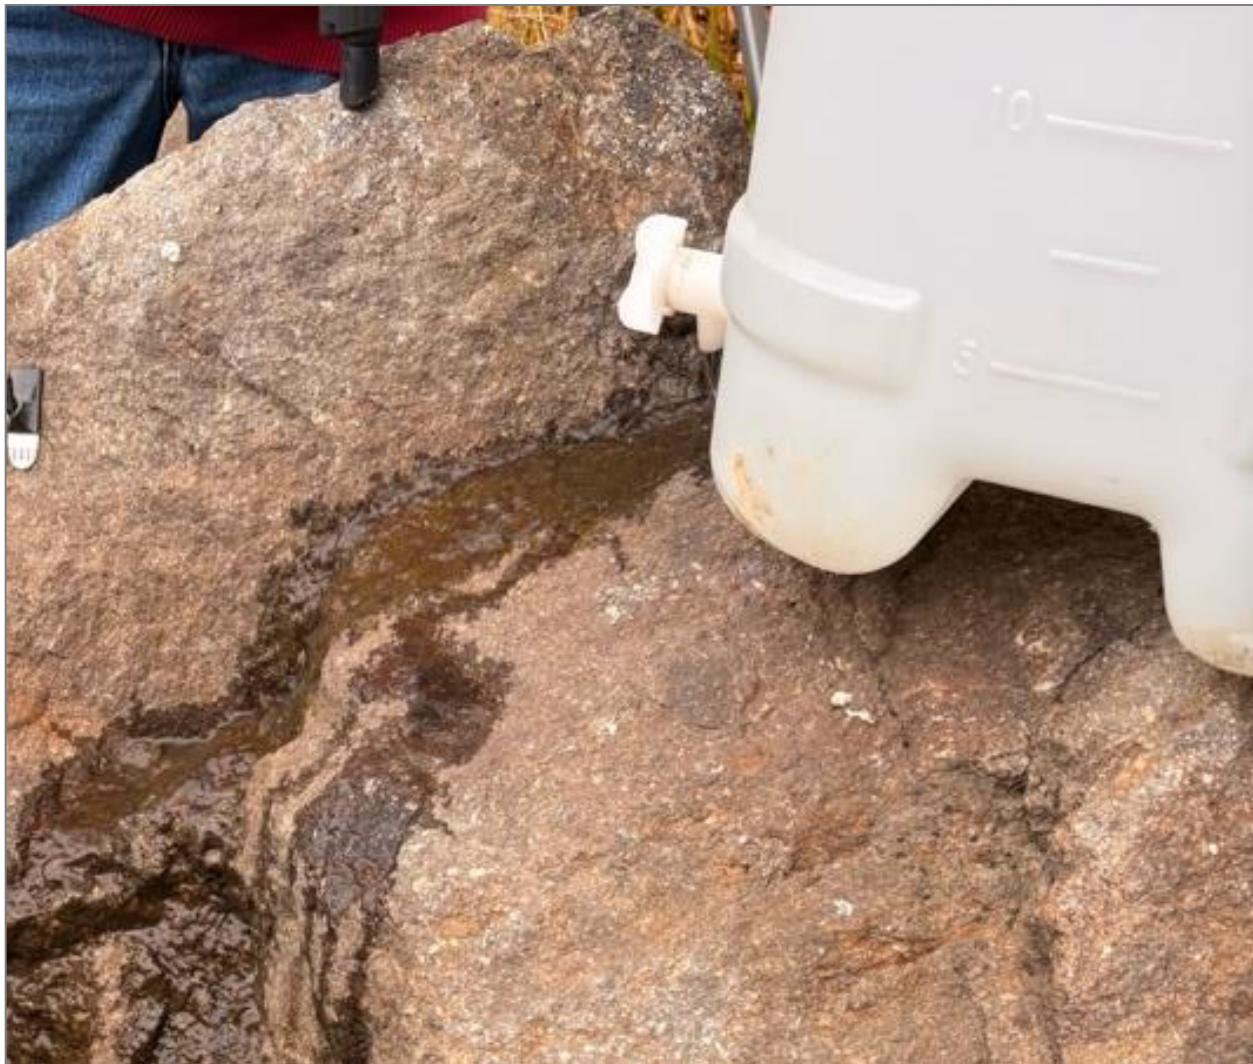
Figure 18: Onsite Testing Water Dispersal Method (Ferguson, 2025).

Site set-up included setting up two cameras, with one showing the whole rock and one aimed at the soil placed within a sling. The 20L water tank used during the in-situ testing was held at the top of the rock, with the hose and pipes removed (Figure 19).

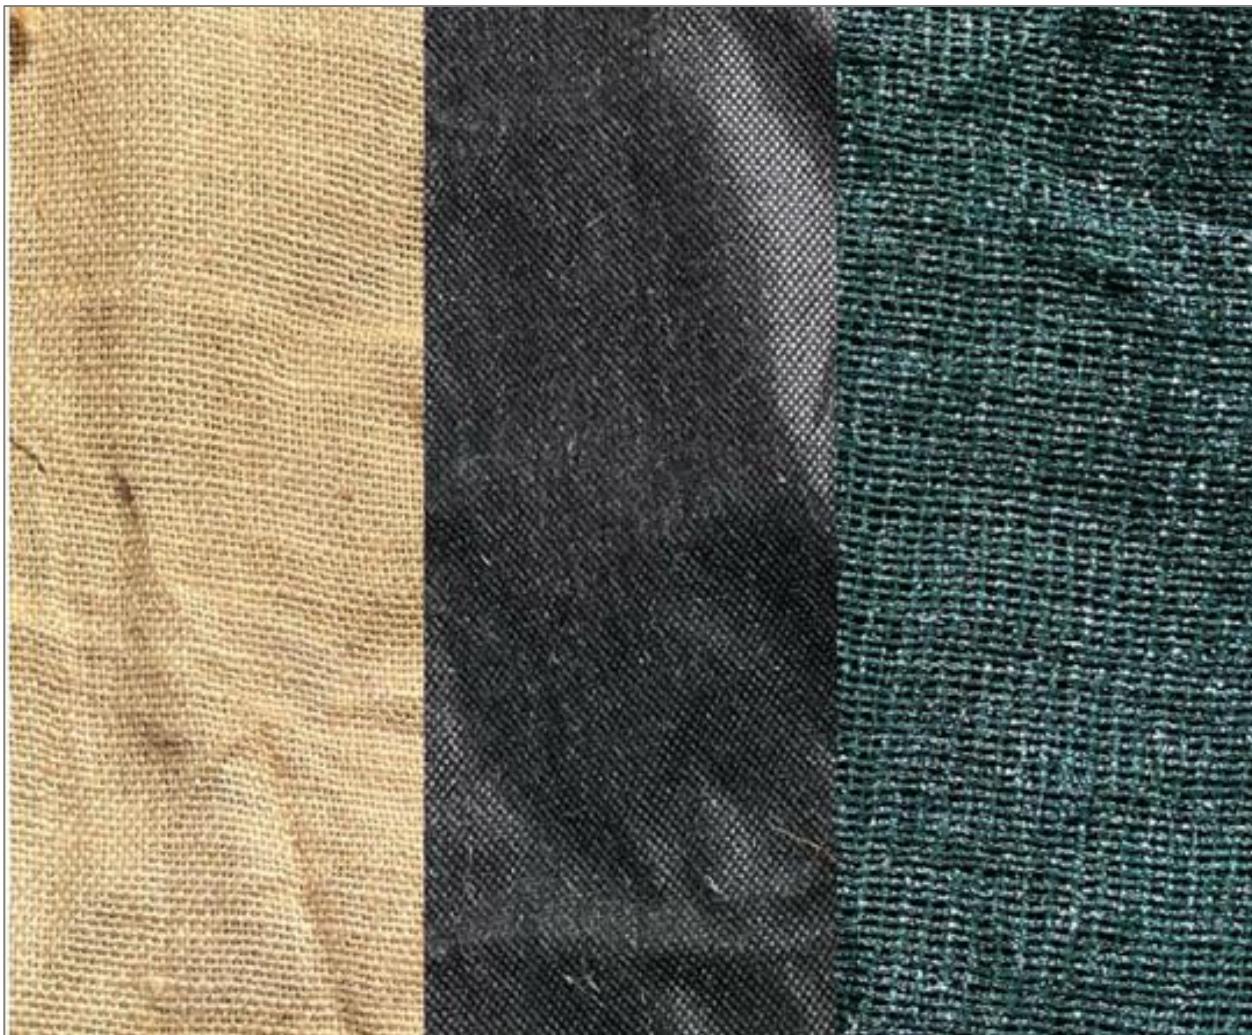
Figure 19: The three materials used in the first onsite field testing, including hessian (left), weed matting (middle), and shade sail (right) (Ferguson, 2025).

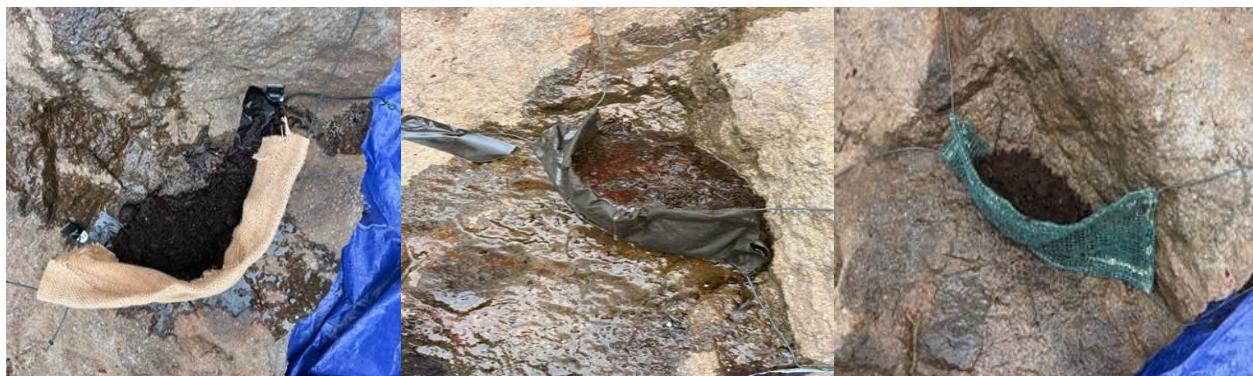
Figure 20: The hessian sling (left), weed matting sling (middle) and shade sail sling (right) during controlled testing (Ferguson, 2025).

A set of three slings, made of hessian, weed matting and shade sail fabrics, was designed (Figure 20). These were attached to the outcrop using four command hooks, while the bottom edge was reinforced and adhered to the rock with duct tape.

Testing began with dispersing water onto the outcrop and scrubbing it to remove debris. Water was run for 3 minutes, and two cups of soil were applied onto the rock in each test to ensure consistency. In the initial hessian sling test, tape was used to secure the bottom of the sling to the rock; however, the side walls were not in full contact with the rockface (Figure 21). This gap allowed soil and water to erode from the barrier. In the second test, the sling was repositioned to sit flush against the rockface. As the rock surface was wet, tape could not be applied, and the soil itself acted as the stabilising force holding the sling in place for the weed mat and shade sail tests (Figure 21).

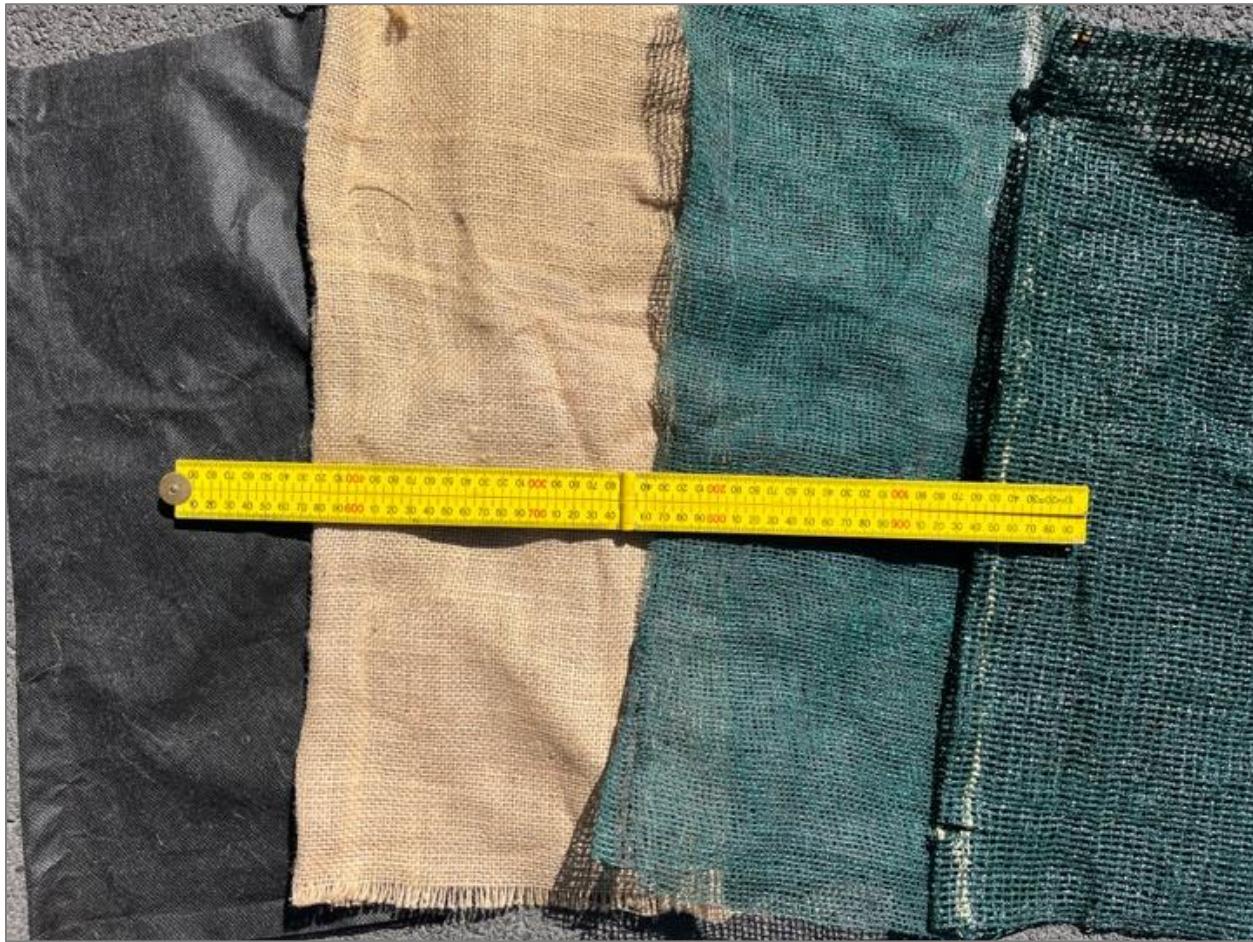
Figure 21: The materials used in the second controlled testing, including weed matting (left), hessian (middle left), finer shade sail (middle right), and shade sail with larger pores (right). A ruler shows their approximate pore sizes (Ferugson, 2025).

The site set up remained consistent with the first controlled testing; however, a fourth material of a shade sail with smaller pores was added (Figure 22). Liquid Nails were used to adhere the slings to the rock, but did not dry in time for testing, so clamps were used to hold the sling in place (a limitation due to time constraints of this project). Water was run for 3 minutes as per the first controlled testing.

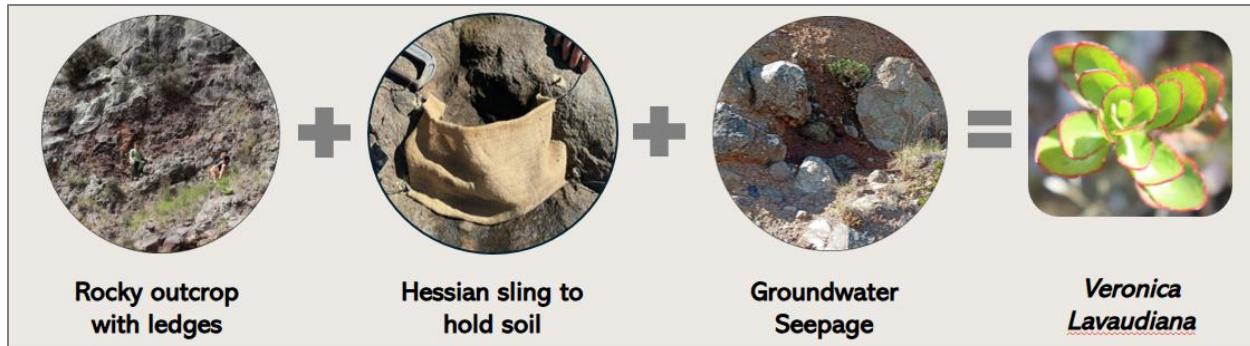
Figure 24: Equation of factors required for plant growth and habitat establishment (Hampton, 2025).

Rocky outcrops require site-specific restoration approaches due to their unique geomorphological and ecological characteristics. The sling product offers a targeted solution for these specific environments. In deforested landscapes with isolated rocky outcrops experiencing extreme surface runoff, this method can be effectively applied to stabilise soil. By providing the structural support for soil retention, the sling provides an environment for the reestablishment of species and habitats (Figure 24).
