# Land remediation assessment in Woolston

Looking at factors influencing poor drainage at Trees  
For Canterbury and options for mitigating the affected  
area

University of Canterbury 10/10/2016

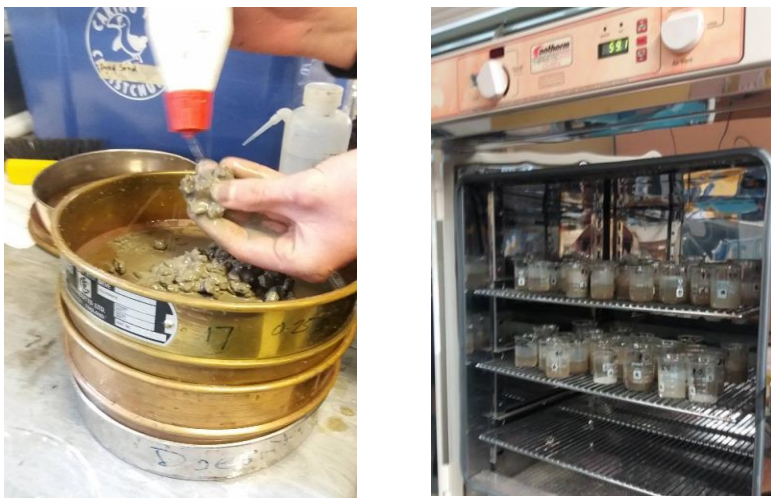
**Figure 3:** LEFT: Separating the clays and silts from sands gravels and pebbles by wet sieving; RIGHT: Samples placed in the oven to remove excess water before further analysis

Most of the samples were moist and therefore smaller grain sizes had aggregated together and stuck to larger grains. So to separate all the grain sizes wet sieving was used, which involved passing all samples through 500um and 63um woven wire mesh sieves using squeeze bottles to separate the grain sizes into 2 categories (**Figure 3**) : 1) >63um ie. Sands, gravels, pebbles; 2) <63um ie. Clays and silts (mud). The finer grains (<63um) were placed into cylinders containing 1000ml of water. The coarser grains (>63um) were put into beakers in the oven overnight to remove excess water (**Figure 3**). During this process the organics were drained off the top, which we classed as things that didn't pass through the 63um sieve and floated in water due to being a low density, softer, and brown in colour. Calgon Solution with the concentration 50g/L, was added to samples that were more cohesive samples (containing clay) to help separate grains.

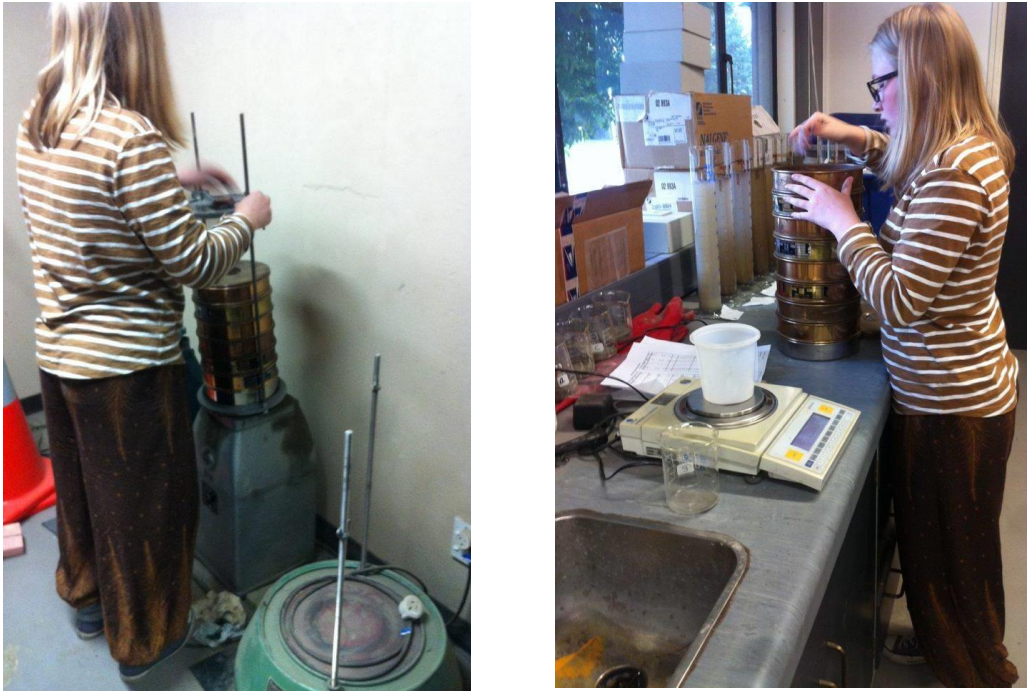
**Figure 4:** LEFT: Using the sieve shaker to sort the grain sizes in our sieves; RIGHT: Weighing the amount of sediment caught in each sieve size to get the amount of each corresponding grain size.

The dried off samples were passed through sieves ranging from 63 $\mu$ m-13200 $\mu$ m. Each sample was placed on a sieve shaker for 5 minutes, which uses vibrations to accelerate the particles in the sieves, this increases the probability of grains to pass through the mesh (**Figure 4**). Grains collected in each sieve were weighed on a tarred beaker and the weights were recorded in a table in excel. Anything that passed through the 63 $\mu$ m sieve was placed into the cylinders containing grains <63 $\mu$ m from our wet sieve analysis.

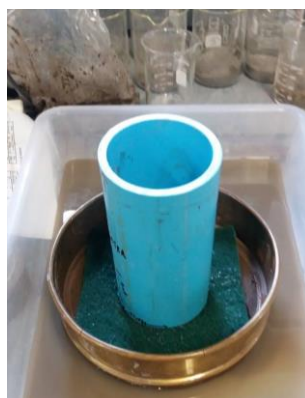
**Figure 6:** The setup of the permeability experiments; this photo shows the sand layer (sample c) being fully infiltrated after 31 minutes.

A permeability test was a method used to indicate how long it takes water to infiltrate each layer. A catch tray, supporting sieve, steel cloth, a stopwatch and a blue cylinder [7.6 (diameter) x 15cm (height)] were used to measure the infiltration of water through the soil (**Figure 6**). For each sample sediment was packed into the cylinder until it was 50mm thick in a way which represented how it was packed in the subsurface at the site (generally this meant tightly packed). 400ml of water was then added to the cylinder and it was timed how long it took for all water to visibly disappear from the surface. Once the surface of the sample was cleared of pooled water, the timer was stopped and this time was noted.

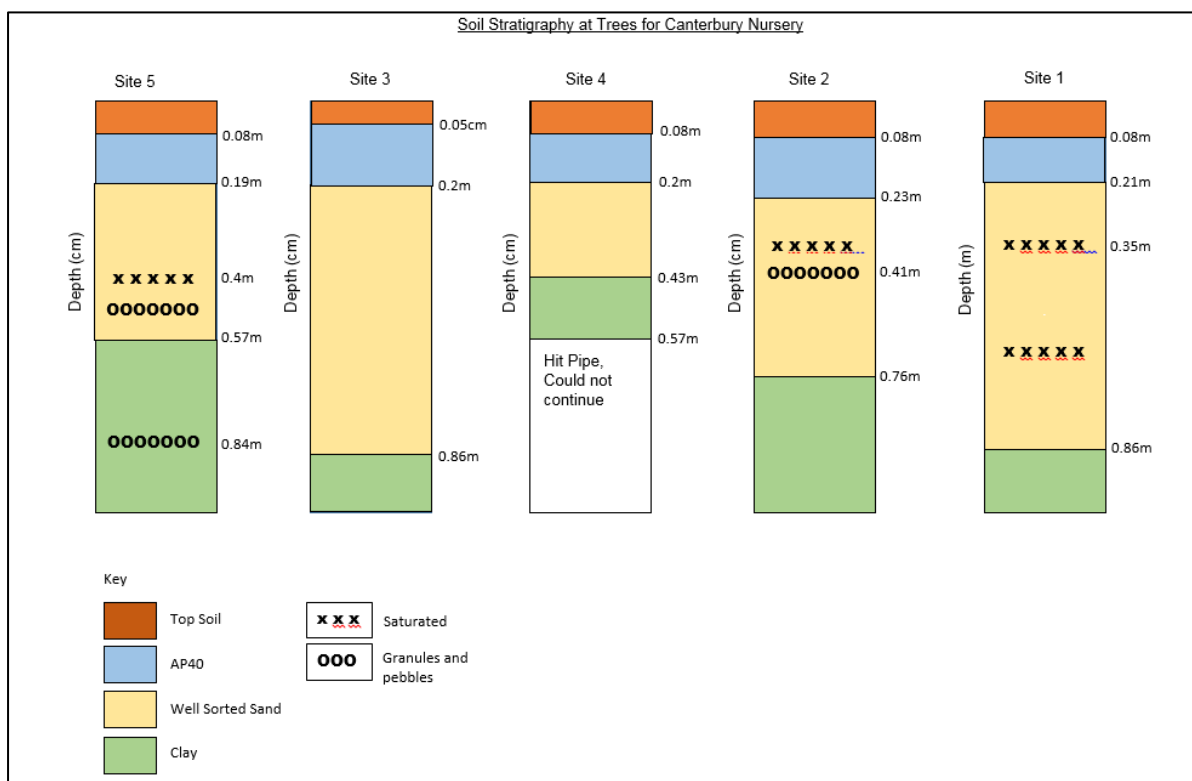
**Figure 8:** Stratigraphic columns showing the thickness of the 4 main units at the 5 different locations tested at the TFC Nursery. The stratigraphic columns here end at 1m, but during follow up visits we ended up coring to a deeper depth through the clay layer, which ended up extending to 1.5m depth.

The core samples taken from 5 different sites at the nursery showed a simple and rather consistent stratigraphy across the whole site (**Figure 8**). The stratigraphy consisted of four main units.

- 8-10cm of Top soil.
- 11-15cm AP40 – Poorly sorted AP40.
- 23-66cm Sand – Ranging from fine to medium grain sized with layers more saturated than others and lenses with granules and pebbles.
- 80cm Clay – highly impermeable layer.

The top soil and AP40 units were of a consistent thickness across the site. The Sand layers varied in thickness across the site and are always followed by a layer of highly impermeable clay.

The water table became of interest when collecting soil samples, as both samples and the hole started becoming moist around 0.7m of depth (**Figure 8**). It is not yet understood whether this area of saturation is a perched water table created by water trapped above the clay layer, or if it is the height of the actual water table. Perched water tables occur when impermeable layers causes accumulations of ground water to become trapped above the actual water table in the unsaturated zone (Bonell & Gilmour, 1978). Council data has shown that the depth of the actual water table has fluxuated a lot in this area, from 0.7 down to 1.5m depth (ECAN, n.d.). Groundwater fluctuates with seasonality, becoming higher in wet seasons due to increase in water resources, and lower in dry seasons where the ground water resource becomes exhausted (Subba Roa, 2006). Seasonality would need to be taken into account when creating a drainage plan at the site.

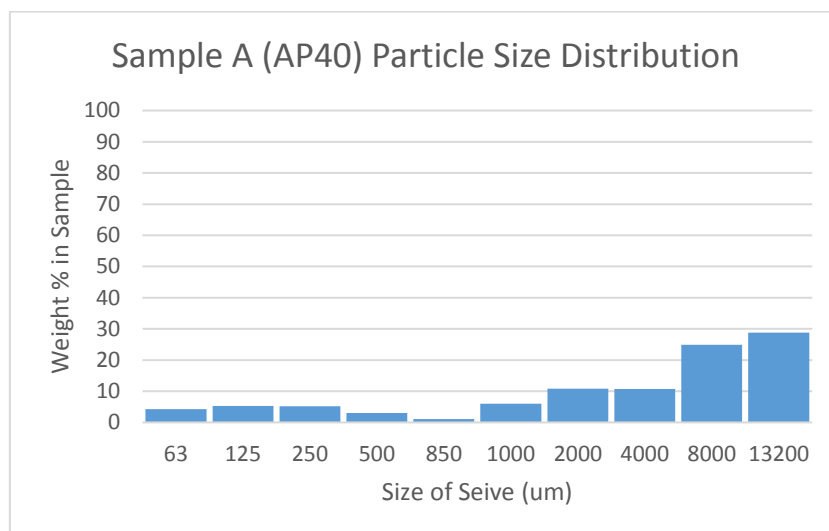
Figure 9: AP40 Particle size distribution showing poor sorting throughout the sample. The total sample weight excluding clay content was 179.89g.

The samples were all relatively the same volume, however the graphs below are not inclusive of the clay content within the sample. Sample A shows a wide variety of grain sizes indicating very poor sorting. Not a lot of clay was extracted from this sample, with it mainly being made up of coarser grains. Sample C and G exhibit much better sorting in finer grain sizes, and it would be hypothesised from these results that these layers show impermeable characteristics due to the relationship between sorting, grain size and permeability, as seen by Masch & Denny (1966). These suggests that the AP40 was likely to be the most permeable and the sand would be permeable to some degree. The clay however would be relatively impermeable. A limitations of the dry sieving is that the permeability is not only a function of grain size and the degree of sorting but is also dependent on how the soil is packed at the site. These graphs can give some indication of permeability, but are not fully indicative of whether or not a unit is permeable or not.

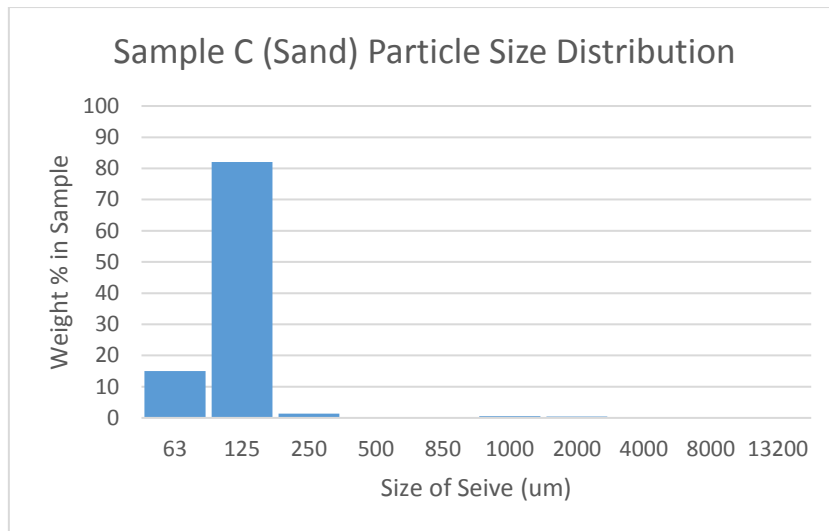
Figure 10: Representative Sand sample from the site showing well sorted sand sized particles. There was 55g of 125um sized particles in this sample.

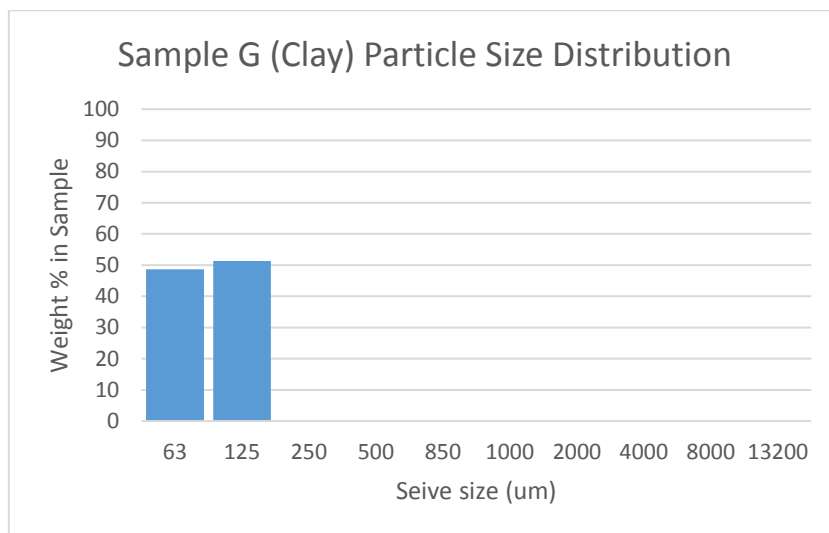
Figure 11: Representative clay sample from the site showing an equal amount of 125um and 63um sized particles. The weight total of these particles from the sample was 9.634g.

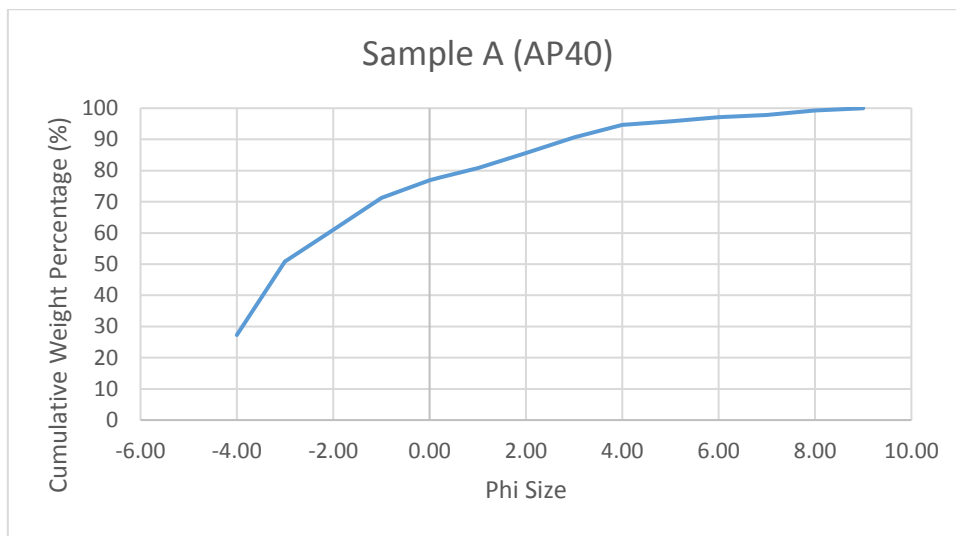
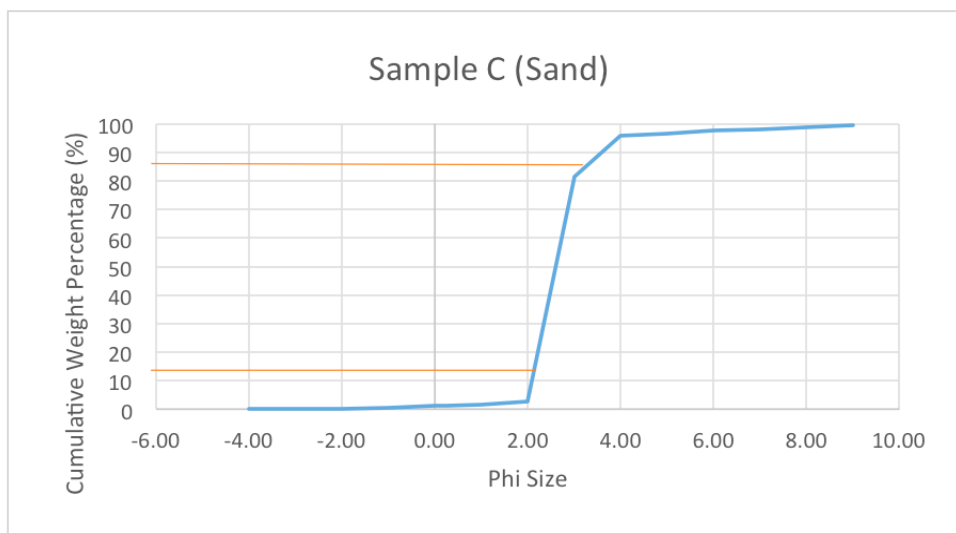
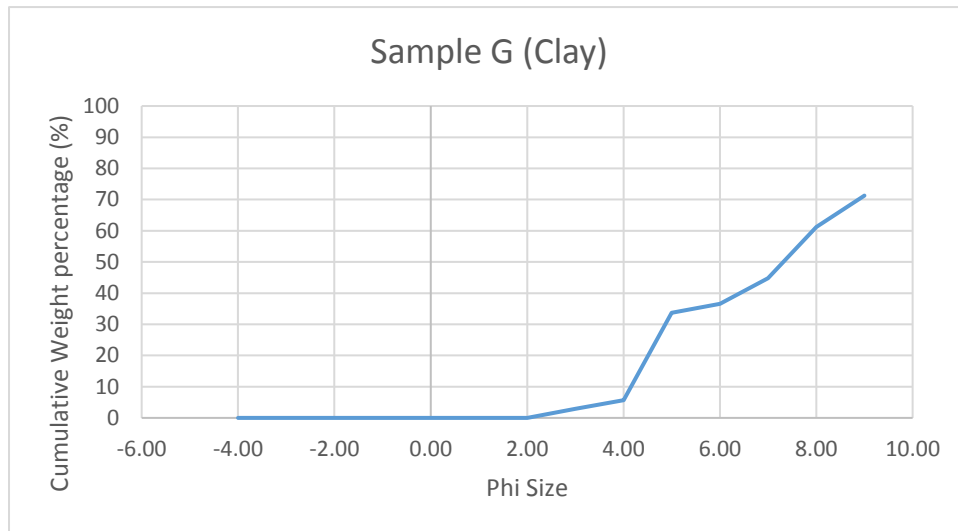
**Figure 12:** The 3 Graphs show the cumulative weight of the particles within the sample from the dry and wet sieving. The orange lines on Sample C are the 16% and 84% marks which help when analysing sorting. This could not be performed on the clay graph as the cumulative total did not reach over 84%. We think this is due to the organics which were taken out of the sample.

Results from the testing show that the sand was the most sorted out of the samples as the difference between the 16% and 84% points on the graph were 1 phi apart (**Figure 12**). The AP40 and the Clay sample did not show 16% and 84% values respectively on the graphs, however when projected on the graph it shows that both are poorly sorted. The clay sample poorly sorted in terms of phi sizes if the graph is projected. The clay is not considered poorly sorted in hand sample as observed there was only a very small sand content, with majority being mud and clay.

The cohesive nature of the clay as well as the fact it is poorly sorted across a very small grain size range indicates there are smaller pore sizes present. There is a significant difference between being poorly sorted across a -6 to -2 phi size range and being poorly sorted across a 4 to 8 phi size range; that being a -6 to -2 phi size range would have larger grain sizes which would leave larger pore spaces between them. The fact that the clay does not reach 100% on the graph is due to around 30% of the sample having a larger phi size than 9.0 which was not recorded.

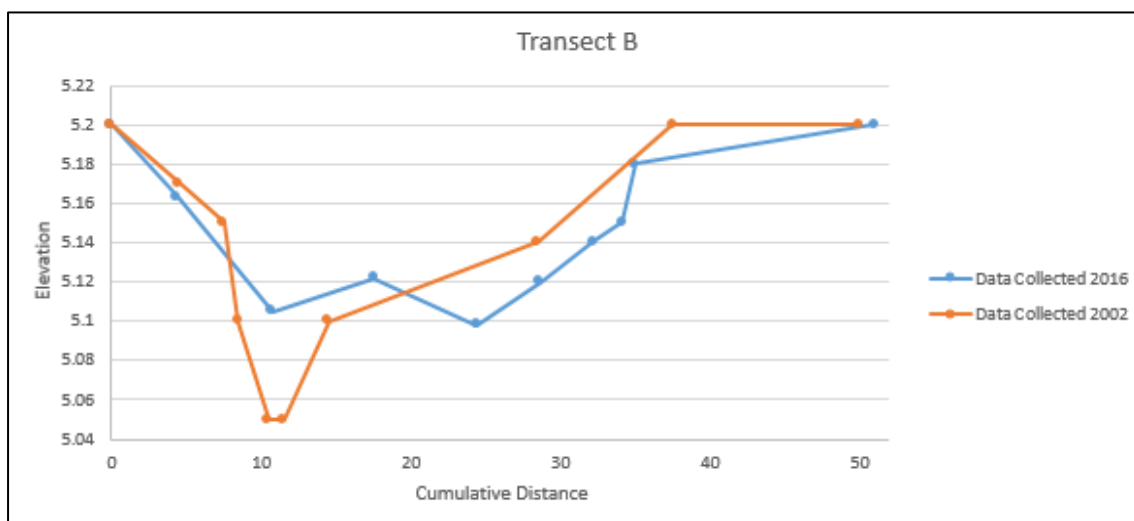
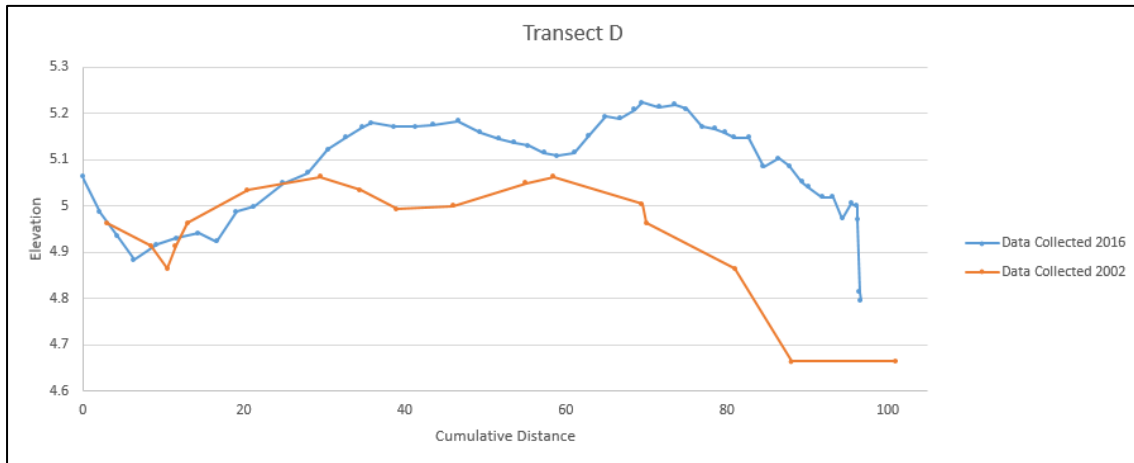
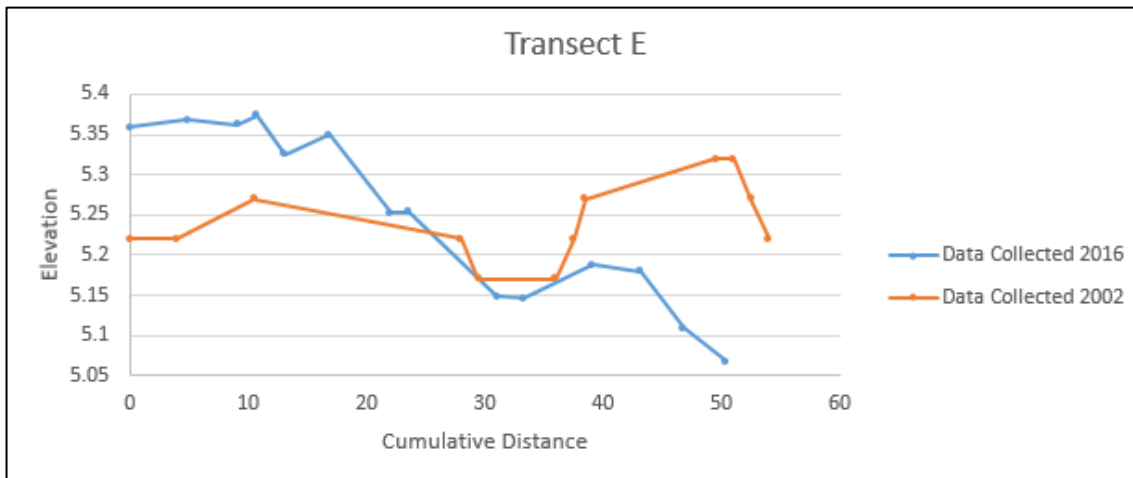
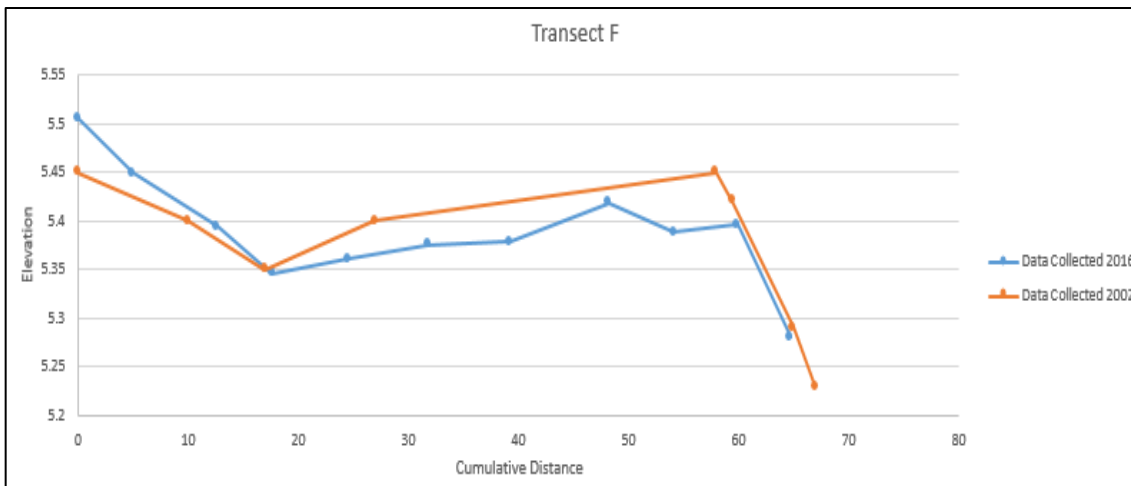
**Figure 13:** Comparable graphs showing the transects which the council collected in 2002, compared to the surveys undertaken by the group in 2016.

Through analysis of the transects, it was found that there were many minor changes in elevation throughout the site. This could be related to land subsidence during the Canterbury Earthquake Sequence in which TFC had extensive liquefaction. Following this, the site was leveled off as best as it could be. Another reason for this difference could be due to human error. Transects created by the Christchurch City Council were navigated to the best of the group's ability. Aspects of the environment hindered the group's capability to obtain confidence in our accuracy. An example of this is transect A in which surveying of the swale at approximately 20m-35m is incomplete due to dense vegetation obstructing the groups transect. Due to this inaccuracy, a more complete survey and research would be needed to investigate how much subsidence has occurred at the nursery. These minor changes and fluxuations in elevation have caused depressions and rises in locations on the site. Areas experiencing depressions are also known locations where pooling and waterlogging has occurred.

Overall the site also showed as a general trend its highest points of elevation located at the centre of the site, with a small, decrease in elevation towards the perimeter. This small gradient should encourage flow of water towards the boundaries.

Surveying results showed that there was small surface gradient from the centre of the site to the outer. It is our interpretation that the small fluctuations superimposed on the general overall surface elevation could lead to water pooling. Even small changes in topography which went against the gradient would result in pooling at the surface. A solution could potentially be to smooth and level out the ground surface, however this could be difficult in a site used for such purposes, as small events such as branches falling from trees and leaf litter could impact the pooling of water on such a shallow gradient.

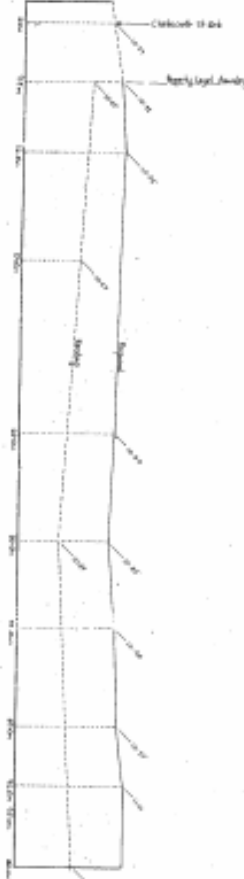
## Appendix B

Original Transects across the site taken in 2002 by the Christchurch City Council. These transects were compared to transects taken in our study.

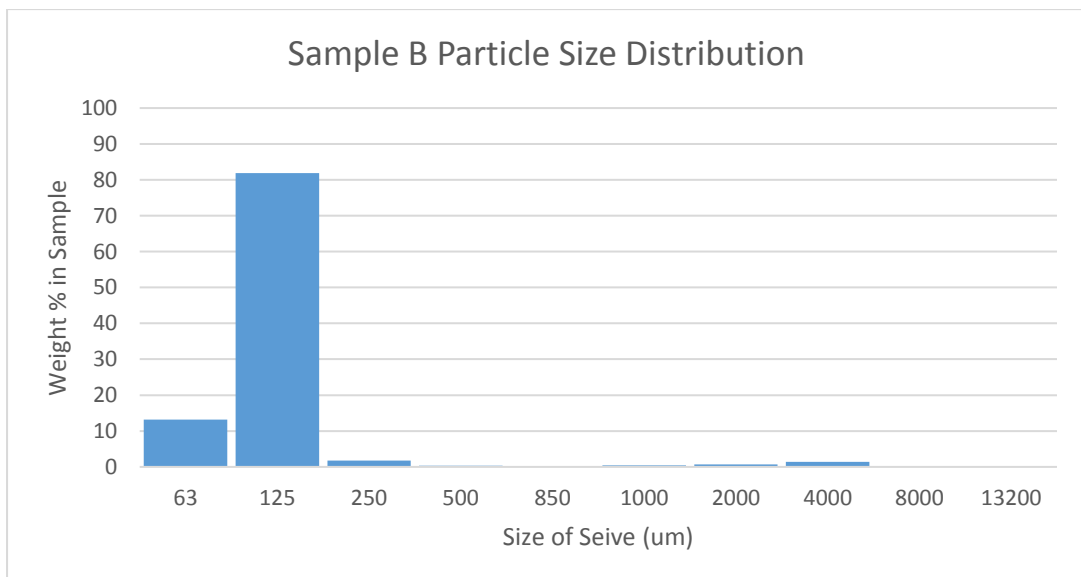
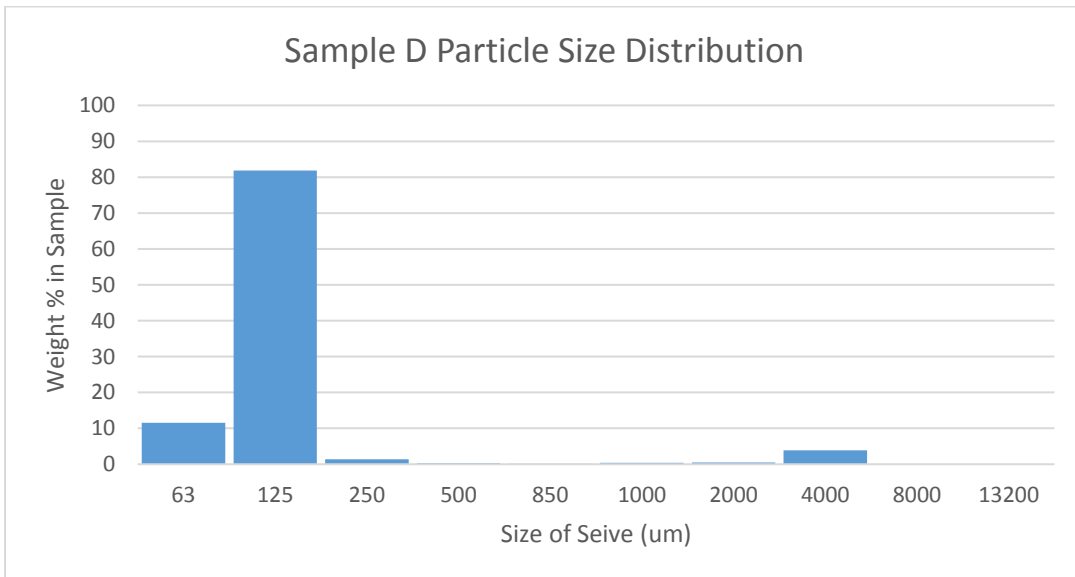
## Appendix F

Graphs of all sample results from the dry sieving tests. The graphs show the weight percent within the sample. The main purpose of the graphs is to display how sorted the samples were. The sorting ranged from poor sorting (sample a) to well sorting in the sand and clay samples. Poorly sorted is when there are particles in majority of the sieve sections.
