Ripples in the Estuary: Anthropogenic Stress and Avon-Heathcote/ Te Ihutai's Ecological Function

Final Project Report, 2023

Dept. of Geography University of Canterbury

Community Partner: L. Bolton-Ritchie, from The Avon-Heathcote Estuary Ihutai Trust Board

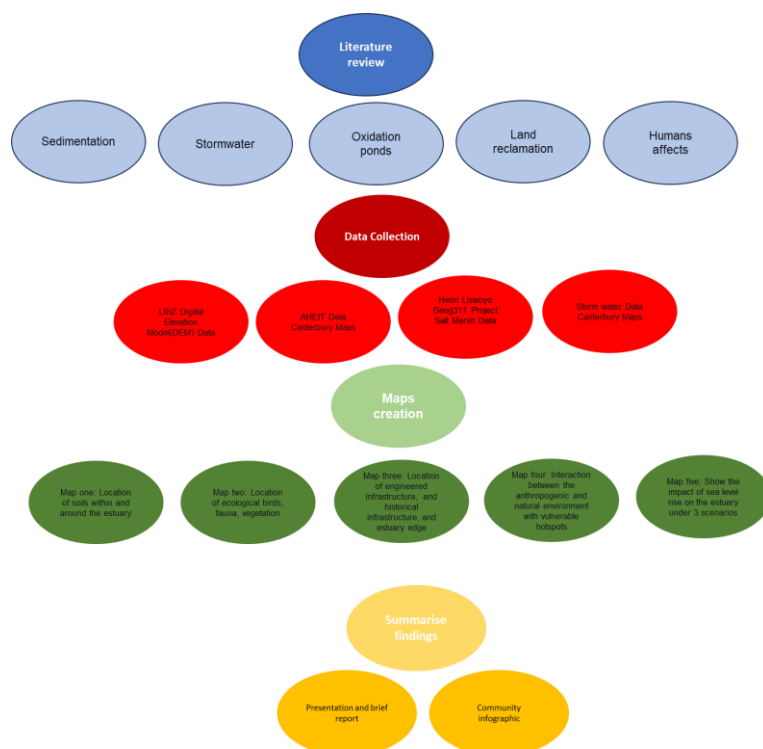
Flow Chart of the Various Methodological Stages Involved in the Project. 3.1.

The methodology used in this project is shown chronologically in Figure 1 and is summarised in depth in the sections below.

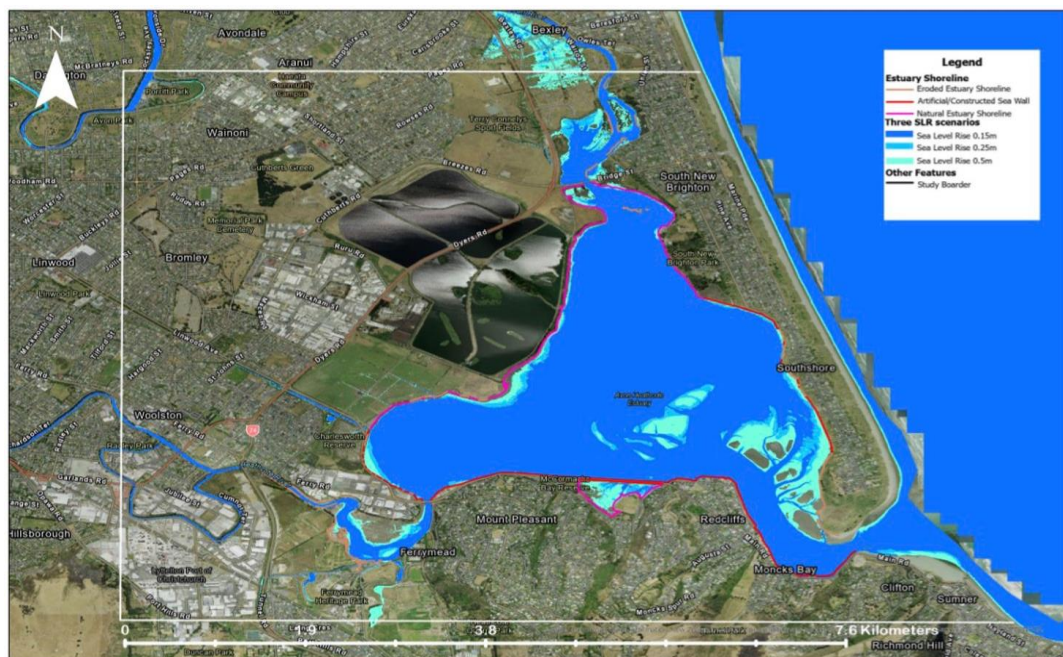
Figure 6 highlights the potential consequences of climate-induced sea level rise on this estuary. This map illustrates three distinct sea level rise scenarios within the estuary, based on IPCC's (International Plant Protection Convention) latest climate change synthesis report, and predicated associated with the SSP1-1.9GHG emission scenario. The emission scenario predicts a sea level rise of 0.15-0.23m of rise is predicted by 2050 (Lee et al, 2023) Hence three specific sea level rise projections chosen for the map are 0.15m, 0.25m, and 0.5m, to reflect IPCC predictions for sea level rise.

Predicted Sea Level Rise Effects on Te Ihutai Under 3 Sea Level Rise Scenarios

predicted sea level rise effects, combined with Figure 4. Interestingly, the sea level is expected to rise in the highest areas near Bexley, Ferrymead, near South Spit, and within McCormacks Bay Reserve. Where there is the significantly built estuary shoreline adjacent to Humphries Drive, there is also an expected sea level rise of $>0.5\text{m}$, as shown in Figure 6. These sections of the estuary shoreline will be significant to the estuary's community groups, particularly the Avon-Heathcote Estuary Ihutai Trust. It will be vital to make note of these and monitor their progress in the future.

Several limitations were encountered in our GIS methods, notably in the creation of the sea level rise map for the estuary. Our study used a bathtub flood model, which assumes uniform flooding or sea-level rise (SLR) at a fixed elevation with a continuous inflow of water. However, it is important to acknowledge that this process is influenced by many factors including topography, ground cover, duration, intensity, and soil conditions (Rahayu et al., 2023).
